## **Forcible Entry Demonstrations Air-blast Resistant Window Systems**

**July 10, 2003  
Final Report**

*Prepared by:*  
Hinman Consulting Engineers, Inc.  
Hollice Stone, M.S., P.E.  
290 Division Street, Suite 302  
San Francisco, California 94103

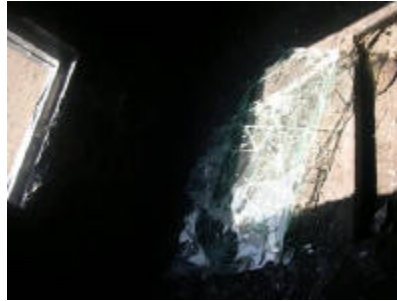
**Figure 4: Test 1 Annealed Glass with Daylight Film**

In one case, the film appeared to make the first break more difficult (four seconds for the window with film versus one second on the control – untreated – window). Venting took longer for the window with the film (average of twelve seconds with film versus one second on the control window). A beneficial side effect of the film treatment is enhanced safety for personnel on lower levels when firefighters attack from an upper floor, due to the decreased number of shards falling.

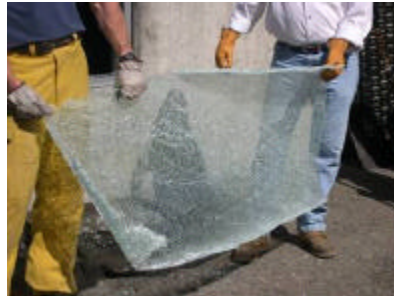
**Figure 5: Test 3 Tempered Glass with Daylight Film**

Overall, it was easier to make entry through tempered glass with daylight film than through annealed glass with daylight film. However, though entry was still rapid, the film caused a delay over what would be expected (based on the past experience of the participating firefighters) from an untreated tempered glass window. Additionally, no shards remained in the frames after the breaks.

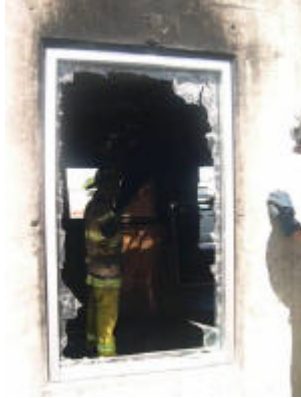
**Figure 6: Test 6  
Annealed Glass  
with 4-Sided  
Attached Film  
Without Center  
Seam**

Times recorded for the four-sided attached film on annealed glass were comparable to those for the daylight film on annealed glass.

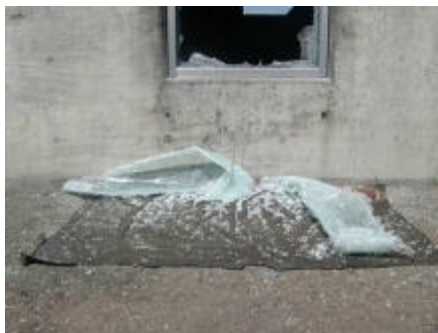
**Figure 7: Tempered Glass  
4-Sided Attached Film with  
Center Seam**

The film created a delay compared to typical break and clear times expected with untreated tempered glass, especially on the second floor where the time to first break was 26 seconds and the time to clear was 64 seconds.

The times to first break and vent were greater for the second-story tempered glass than for the second-story annealed glass (tempered – 26 seconds to break and vent and annealed – four seconds to break and ten seconds to vent), though the final clear times were comparable (64 seconds for tempered and 71 seconds for annealed).

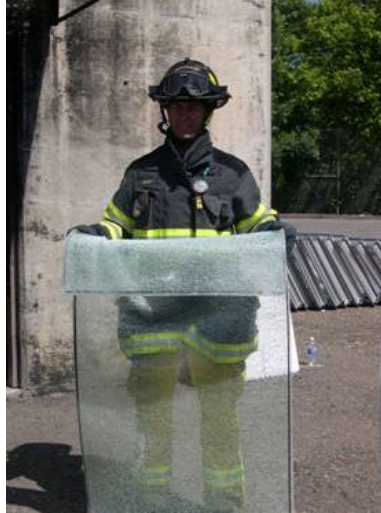
**Figure 8: Test 26  
Laminated Single  
Paned Tempered Glass**

The laminated, single-paned window panes became a flexible mass when broken, especially the tempered glass panes. This allowed the firefighter to use the weight of the tool to push the entire unit out of the framing system rather than requiring them to chop around the entire window perimeter, as was done for the attached window film systems. This tended to decrease the time for venting and clearing of the windows.

Break, vent, and clear times for the laminated single-paned units were comparable to the daylight film configurations, but were less than for the attached-film configurations. Heavier tools tended to improve the vent and clear times.

As with the tempered glass with daylight film, no glass shards remained in the frame after the break.

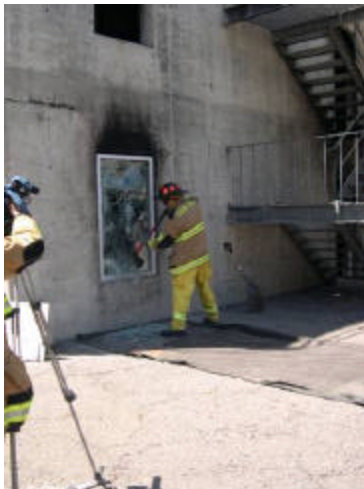
**Figure 9: Laminated  
Annealed Insulating  
Glass Unit**

First break for the laminated annealed insulating glass units was approximately twice that of the first break time for the single-paned laminated annealed insulating glass units. The firefighters found that a good way to gain access through insulating glass units was to first ensure that the non-laminated annealed panes were fully broken before addressing the laminated panes. This allowed them to exploit the same flexible-mass effect they had observed during the single-paned laminated glass demonstrations.
