# San Francisco Veterans Affairs Medical Center *Historic District Design Guidelines*

August 2015

U.S. Department of Veterans Affairs, Office of Construction and  
Facilities Management, Washington, D.C.

Contract No. VA101CFM-P-0096  
Task Order VACFM05-0018

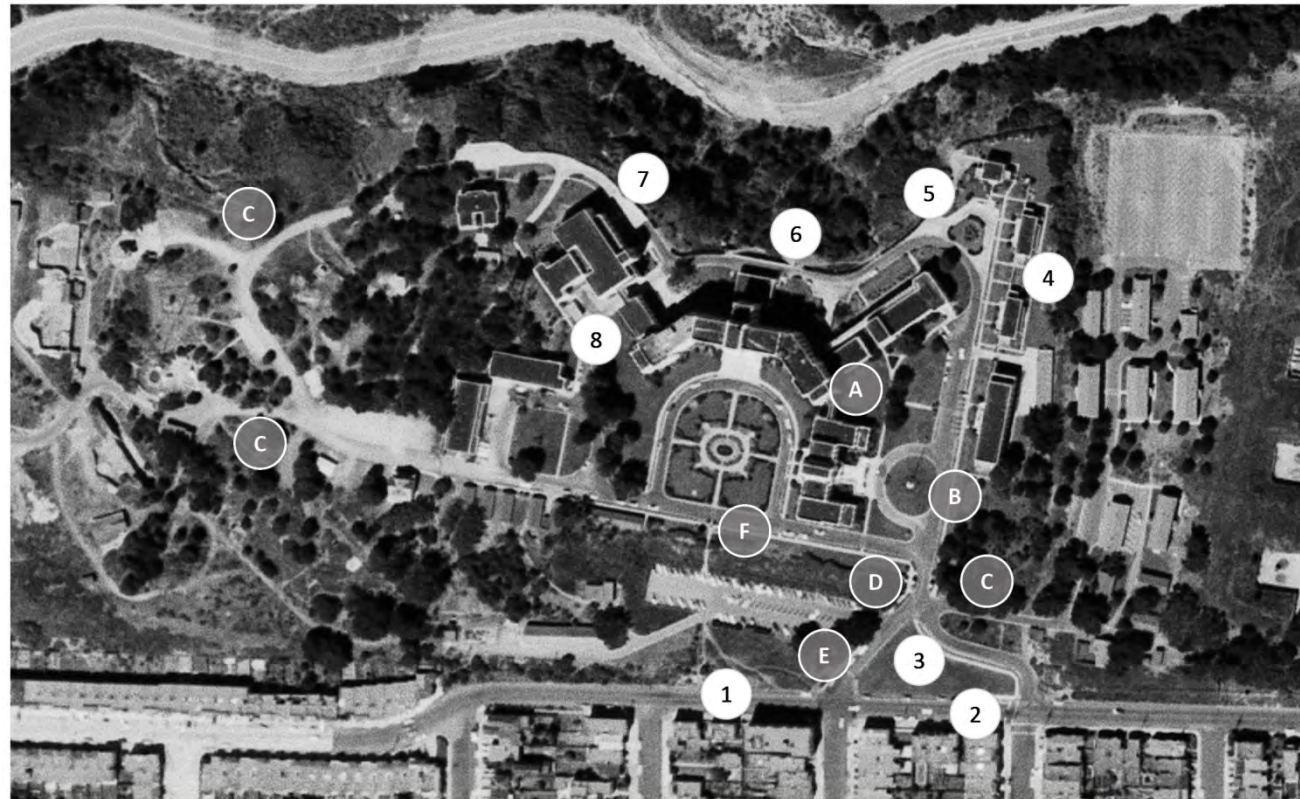
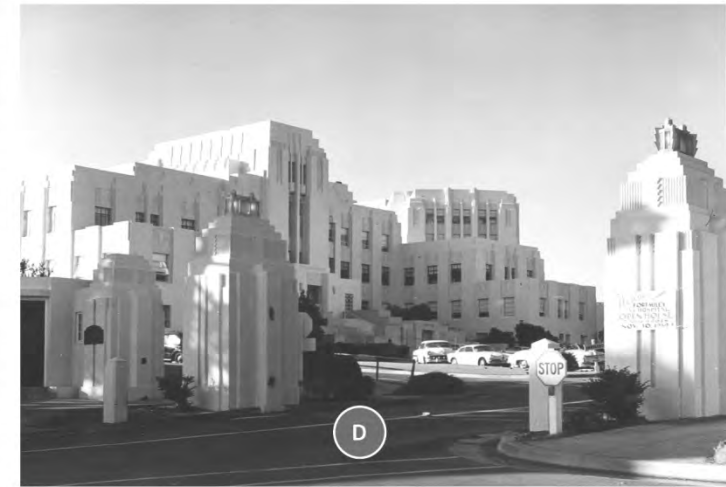
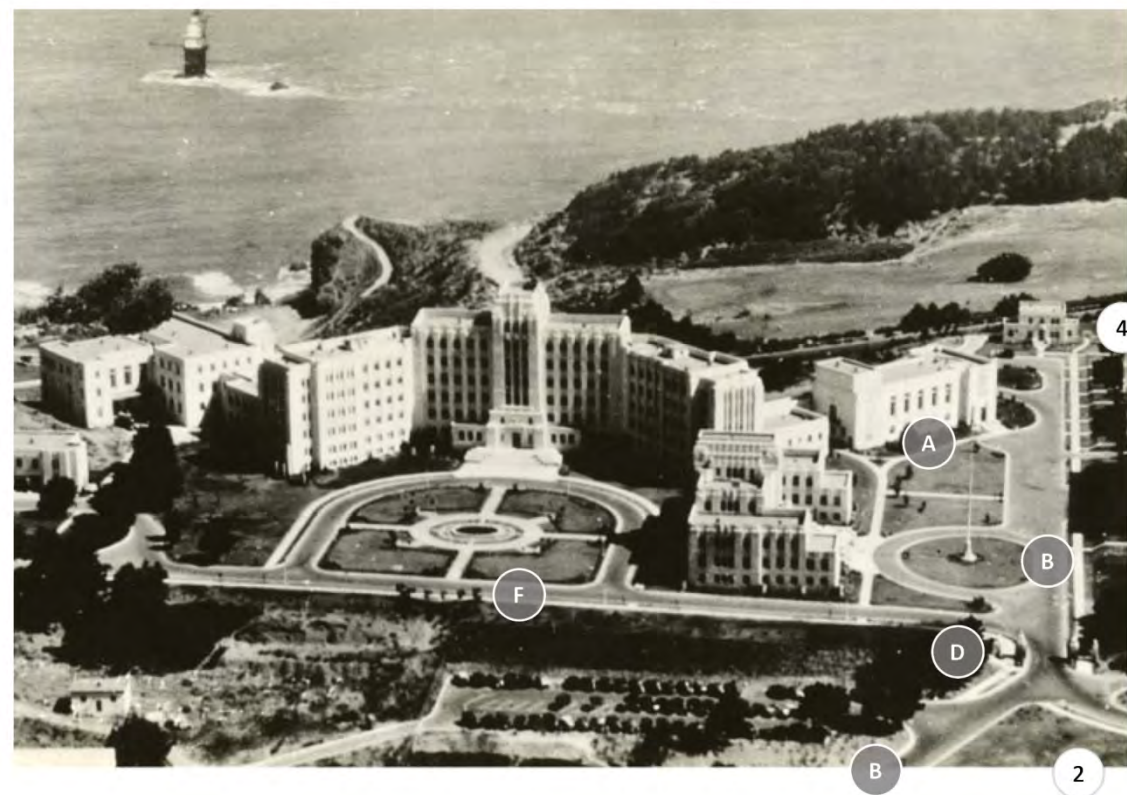
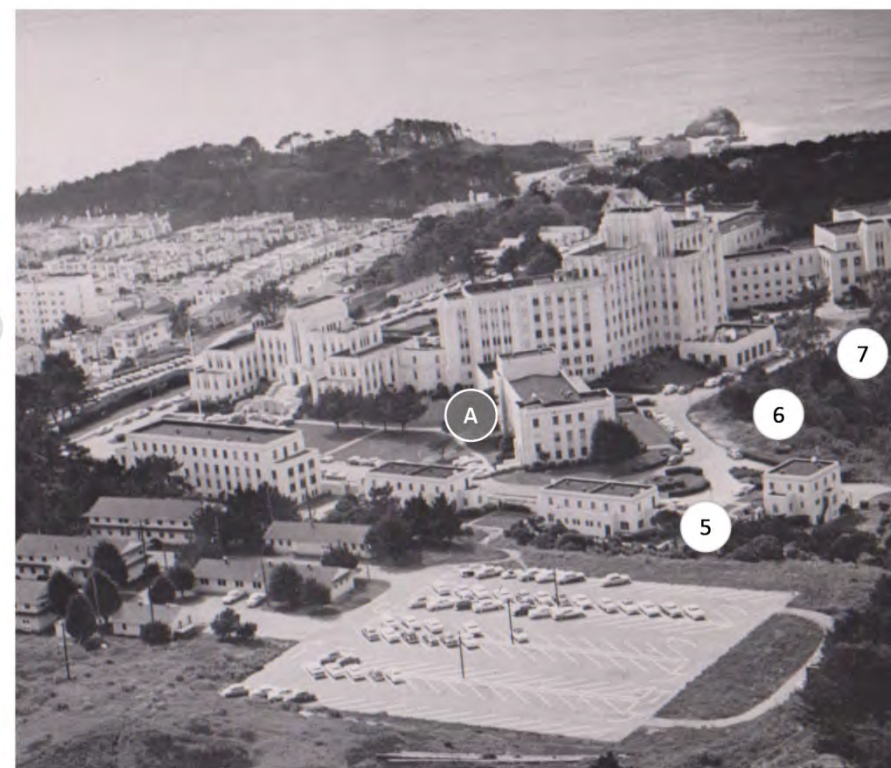
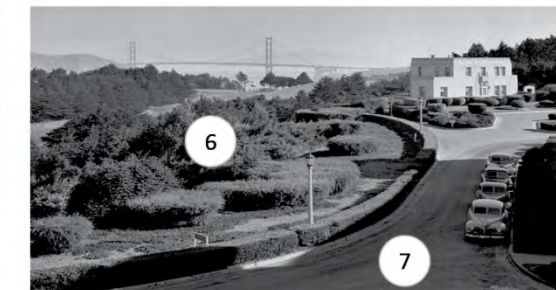
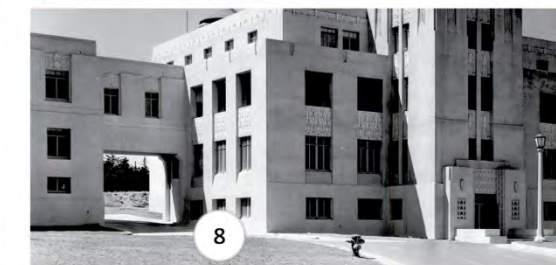
- 1 Steeply sloping and heavily planted buffer space between south edge of campus and Clement Street
- 2 Landscaped lawn between original location of entrance gate and Clement Street
- 3 Curving entrance drive up to original location of entrance gate with signature view of Buildings 1, 2, and flagpole
- 4 Lawns with sloping berms and pedestrian sidewalks in front of Buildings 8, 9, 10, and 11
- 5 Landscaped circulation island, lawn and curving drive that dramatically reveals the signature view to the north
- 6 Landscaped buffer and undeveloped "slide" along north ridge
- 7 Curving drive along north ridge
- 8 Service drive under elevated walkway to side entrance of Building 6

- A Landscaped lawns with shade trees and pedestrian walkways in front of Building 1, 5, and 7
- B Horseshoe-shaped driveway surrounding a forecourt and flagpole on axis with the front entrance of Building 1
- C Access roads into west and east Fort Miley
- D Front art deco entrance gate with four pylons, a decorative metal gate and a sentry post
- E Vehicular drive from 43rd and Clement St. to entrance gate
- F Large horseshoe-shaped driveway surrounding a formally-landscaped forecourt on axis with the front entrance of Building 2

Figure 7. Depiction of landscape features that historically were present at SFVAMC (photos courtesy of the VA).

The original SFVAMC site plan was elegant, formal, and welcoming: the wings of the Building 2 complex spreading wide behind a large landscaped forecourt and horseshoe-shaped entry drive (see *Figure 7*). Because the property previously had been used by the Army as part of Fort Miley, there were few trees and bushes at the time, with clear views in most directions; for example, toward the Palace of the Legion of Honor. Under the pressure of growth in the veteran population during and after World War II, and in response to evolving seismic requirements, the coherence of the site plan was largely lost, with Buildings 200 and 203 replacing the forecourt and creating a massive barrier between the VAMC and the neighborhood, and with other new buildings springing up at various locations across the campus (see *Figure 8*). Such coherence as remains is to be found in the area east of Building 1 with its monumental entry and flagpole. This area has substantially been transformed into a surface parking lot, but remains an important focal point that can and should be used positively in the design of new construction and landscaping.

From Clement Street at 42<sup>nd</sup> Avenue, the viewshed opens up onto an entrance lawn, with Building 1 and the Flagpole beyond (*Figure 15*). The driveway that currently curves down to Clement Street and 42<sup>nd</sup> Avenue was historically present (as shown by *Figures 7 and 8*); historically, though, the driveway also included a separate leg that curved down to Clement Street and 43<sup>rd</sup> Avenue, which is no longer present (*Figure 8*). Although the non-historic parking garage (Building 212) at the entrance partially blocks the view into the campus, Building 1 and the Flagpole remain visible and provide a reminder of historic ingress into the compound. The removal of the original Art Deco entrance gate that once marked this entryway, and revision of the drive have, changed the aesthetic character of this location and diminished the sense of entering the campus (*Figure 16*). Should the VAMC elect to replace the entrance gate, it should be reconstructed in a manner consistent with the *Secretary's Standards for Restoration*. (Refer to the discussion of "When to Restore" on page 14). The view from Clement Street at 42<sup>nd</sup> Avenue marks the historic entrance into the hospital campus.

Historically, a curving driveway exited the campus going to both 42<sup>nd</sup> and 43<sup>rd</sup> avenues at Clement Street. (Refer to aforementioned *Figure 7*). Looking inward, to the north, a view toward Buildings 1 and 2 and the Flagpole was open beyond. Today, though, the historic exit driveway at 43<sup>rd</sup> Avenue has been removed and replaced with lawn. A new exit from behind Building 203 goes to 43<sup>rd</sup> and Clement Street. Other changes include the installation of a new service drive to the west of the location of the historic driveway and the construction of Buildings 203 and 200 that largely block the view of historic Building 2 (see *Figure 17* below). However, the south façade of Building 1, the Flagpole, and the entrance lawn remain largely visible from this vantage point. This view represents a key location that enables patients, staff, and the public to understand and appreciate the campus' historic character and, consequently, should be preserved.

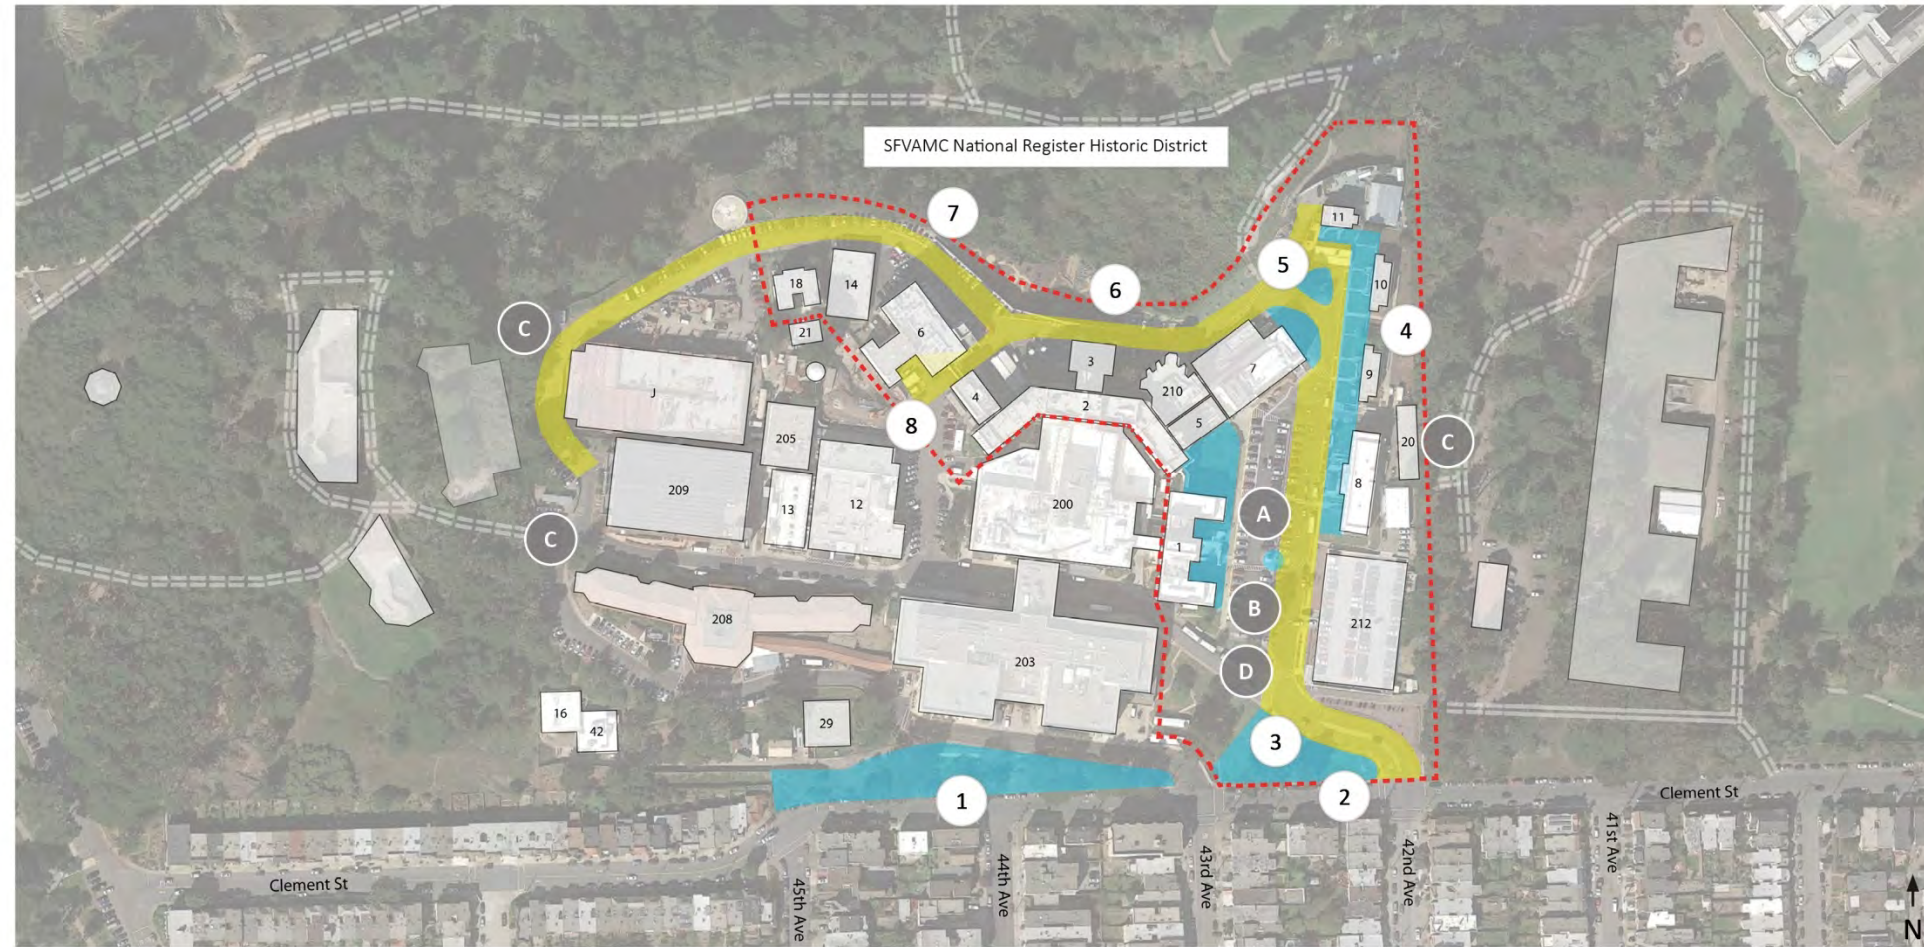
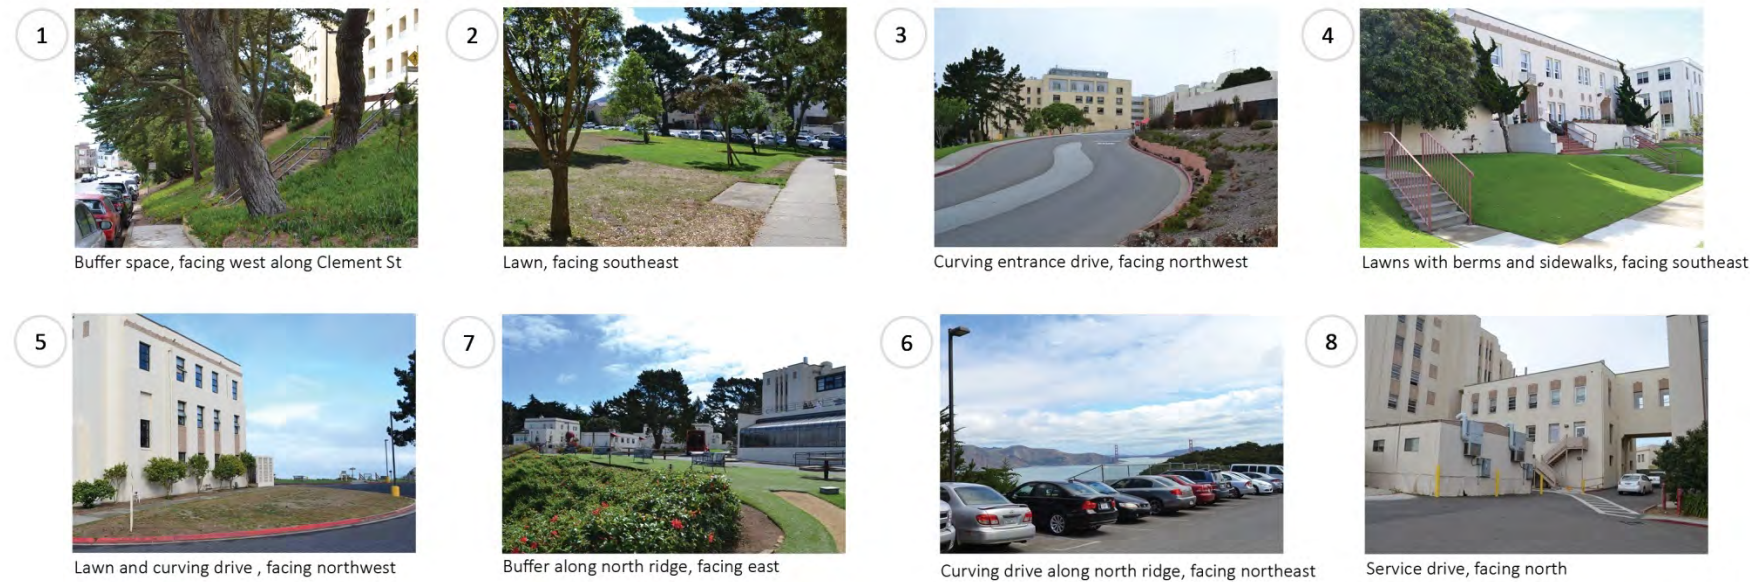
**CHARACTER-DEFINING LANDSCAPE FEATURES**

- A Restored open landscaped lawn and pedestrian paths (see Feature A in "Historic Landscape Features")
- B Restored circular driveway and landscaped forecourt around flagpole (see Feature B in "Historic Landscape Features")
- C New and improved pedestrian paths into east and west Fort Miley
- D Restored ceremonial entrance gate (see Feature D in "Historic Landscape Features")

Figure 8. Depiction of extant historic landscape features that are character-defining features of the historic campus.

The significant Mayan Art Deco historic buildings and associated landscape features within the SFVAMC Historic District are depicted in *Figures 7 and 8* earlier in this report, and listed in further detail in the NRHP inventory provided in *Appendix A*. As stated by the *Secretary of the Interiors' Standards* in Standard No. 2, "The historic character of a property shall be retained and preserved. The removal of historic materials or alteration of features and spaces that characterize a property shall be avoided." All reasonable efforts should be made to avoid positioning new construction so that it demolishes or destroys any of the significant historic buildings and landscape features within the SFVAMC Historic District and the adjacent FMMR Historic District.

- If careful analysis indicates that there are no suitable building sites within the low-impact areas depicted in *Figure 33*, then new construction within the SFVAMC Historic District boundaries and/or significant viewsheds may be necessary. Whenever feasible, site selection should avoid demolition of the significant historic buildings and landscape features that are illustrated in *Figures 7 and 8* within the *Introduction*.

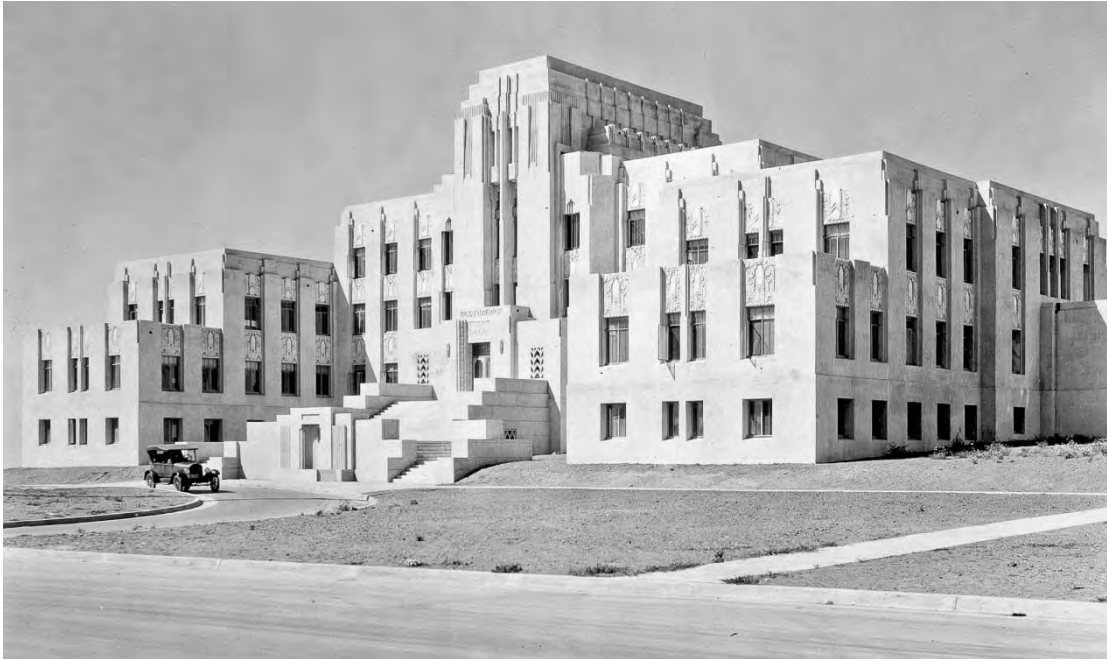
Figure 11. Historic photograph of Building 1, ca.1934 (courtesy of SFVAMC).

**Maintain, restore, and seek compatibility with the campus' Mayan Art Deco architecture.** (See *Figure 11* to follow.) Those examples of Mayan Art Deco design and detailing that survive should be carefully stewarded. Where physically, legally, and financially feasible, those Mayan Art Deco elements that have been buried or obscured should be recovered and restored. Consistent with the *Secretary of the Interior's Standards* for new construction in historic districts, new construction should respect the Mayan Art Deco theme without replicating it.

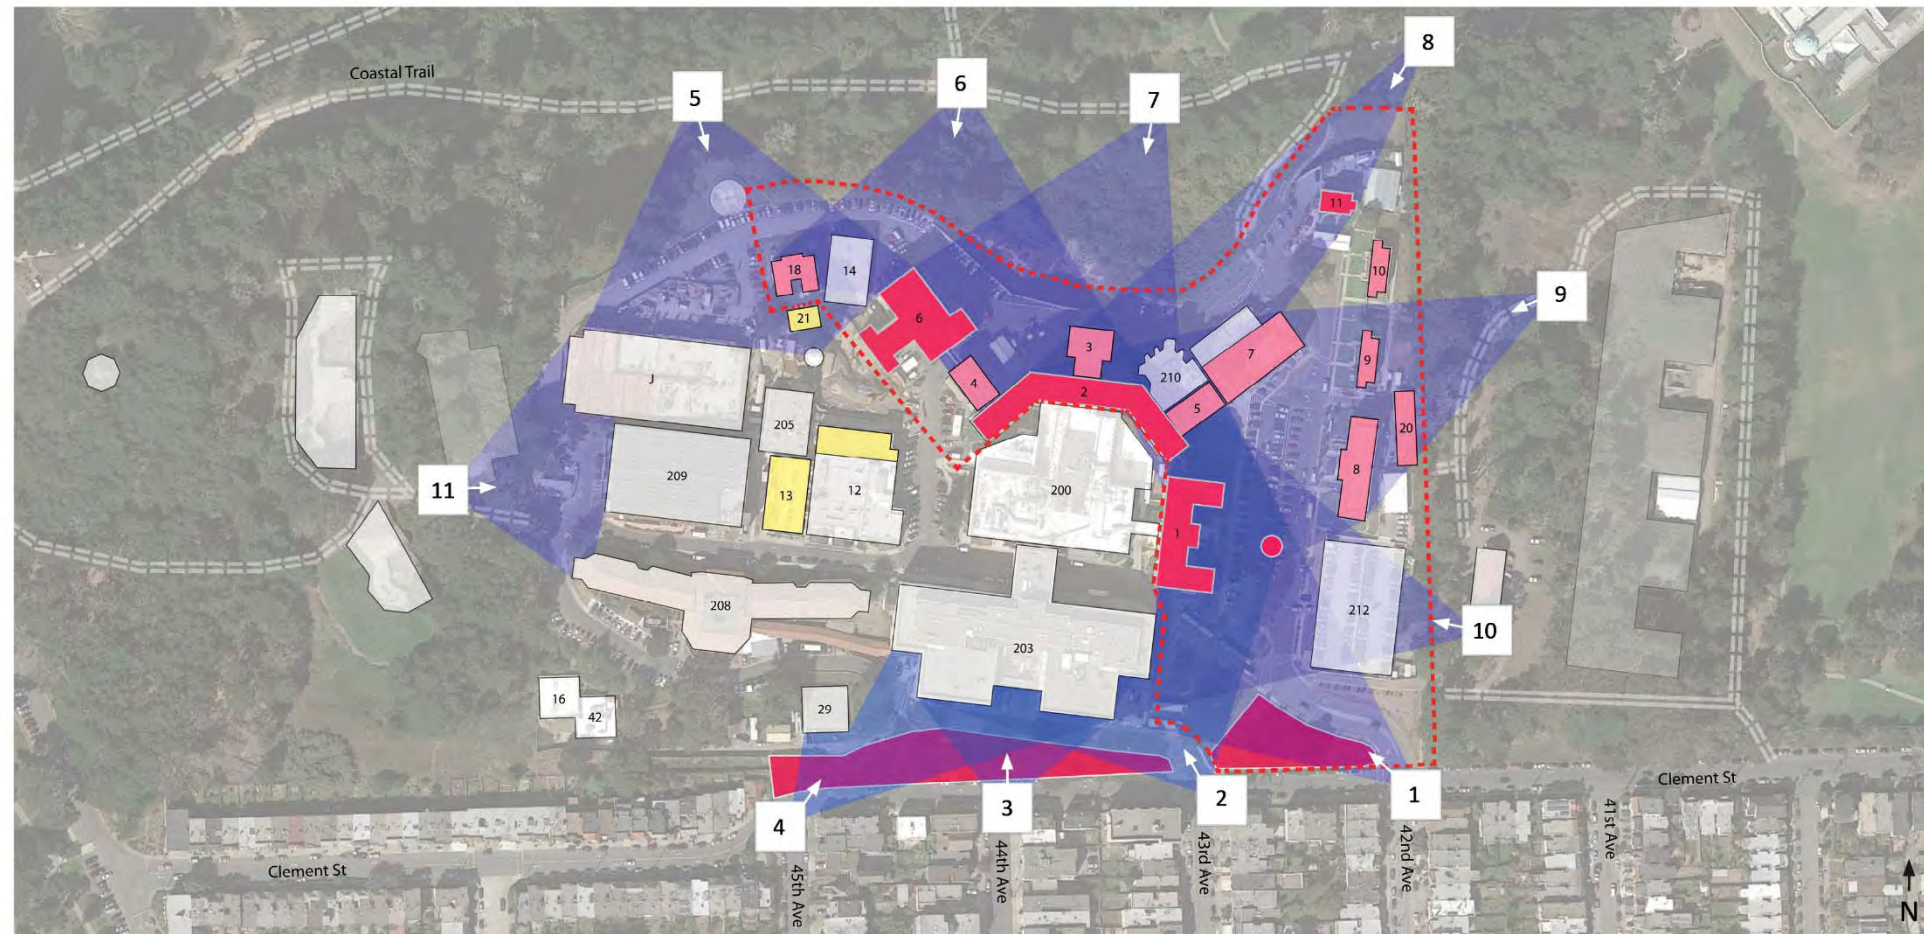
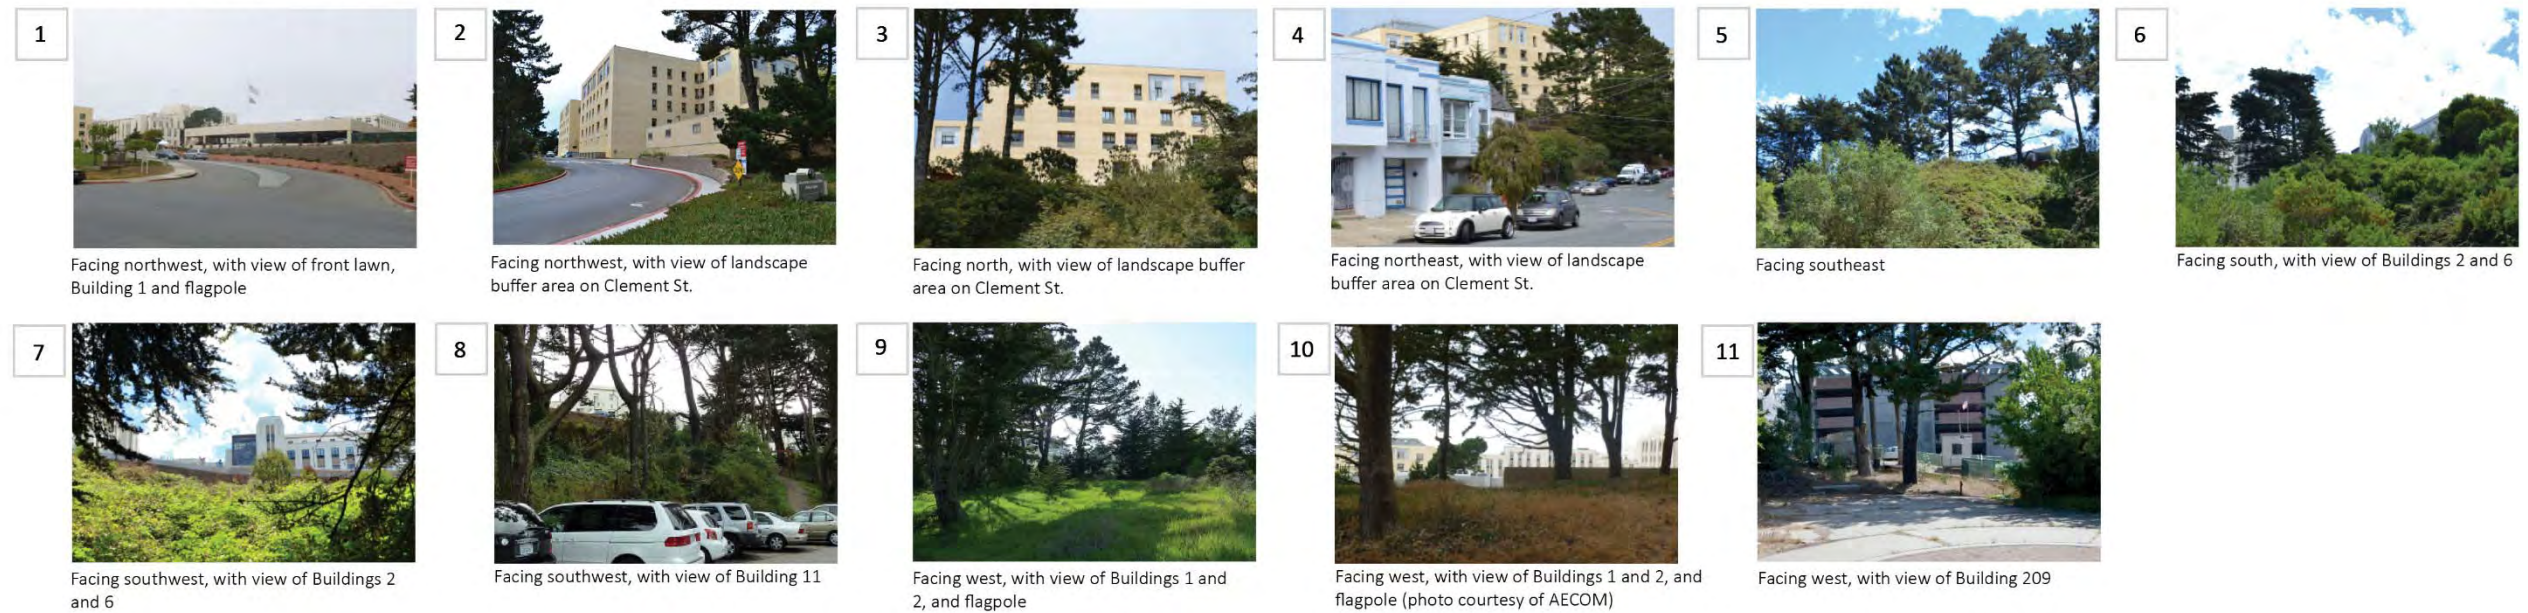
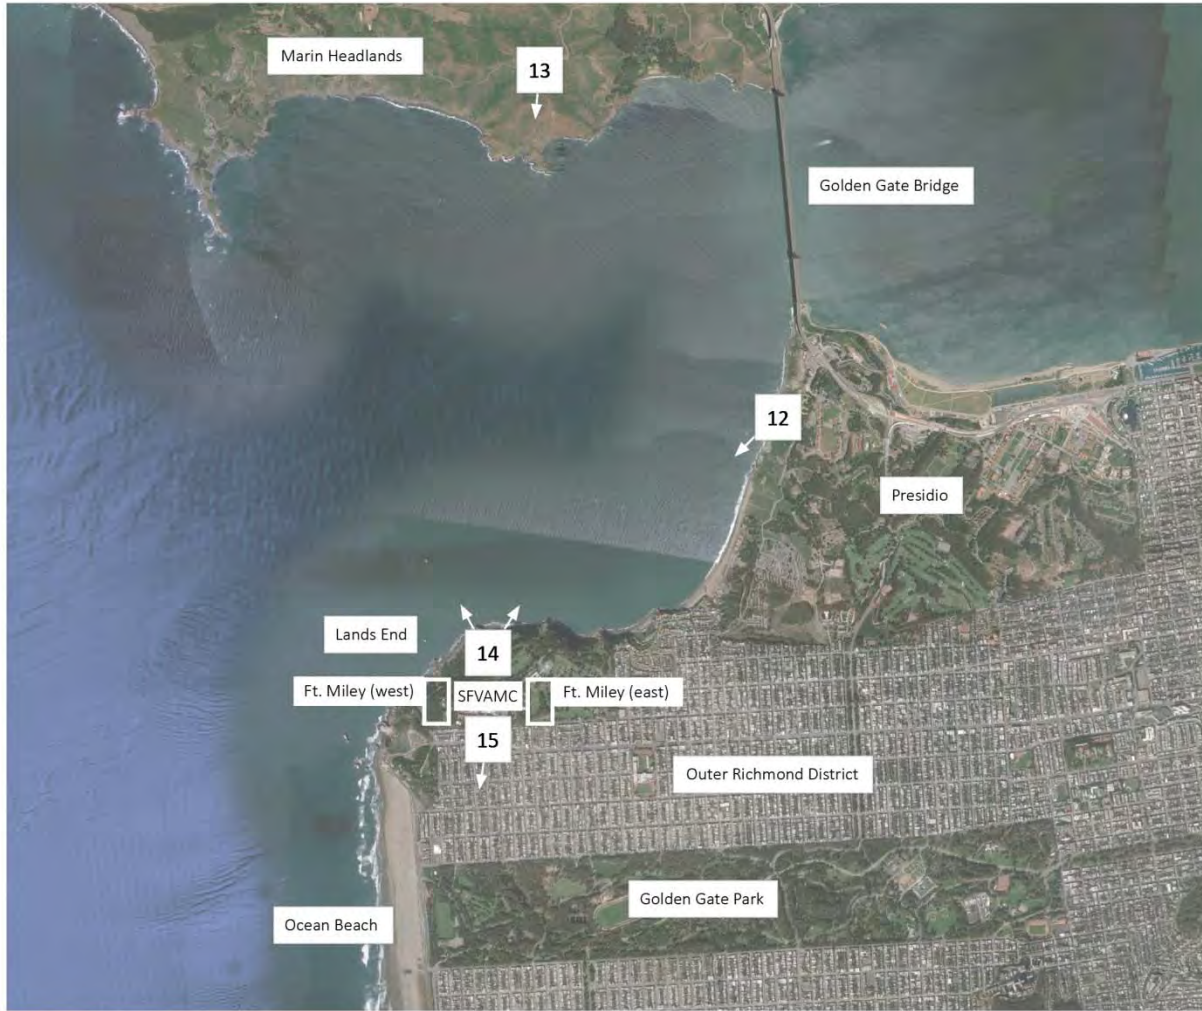
**SIGNIFICANT VIEWPOINTS**

- - - SFVAMC NATIONAL REGISTER HISTORIC DISTRICT BOUNDARIES
- HISTORIC 1934 BUILDINGS WITHIN HISTORIC DISTRICT
- HISTORIC 1934 BUILDINGS OUTSIDE HISTORIC DISTRICT
- HISTORIC 1934 RESOURCES VISIBLE FROM VIEWPOINTS

Figure 13. Depiction of significant viewpoints toward the SFVAMC Historic District (photos by HHM, 2014). (Refer to Appendix G for additional and larger photos.)

During the development of the 2012 *Draft Environmental Impact Statement (EIS): San Francisco Veterans Affairs Medical Center (SFVAMC) Long Range Development Plan (LRDP)*, SFVAMC examined 12 viewpoints looking toward the campus that each contribute to the significance of the historic district. These design guidelines use the viewpoints set forth in the *EIS*, with some slight modifications to reflect more recent concerns expressed by SFVAMC neighbors and consulting parties in the NHPA Section 106 process. In addition to the 12 viewsheds looking in toward the campus, SFVAMC is significant because of its views looking out toward the Golden Gate to the north/northwest and toward Ocean Beach to the southwest. The viewpoints are depicted on the maps in *Figures 12 and 13* and discussed below. (Additional, larger photographs are included in *Appendix G*.) The following analysis examines the character, integrity, and likely relative significance of each of the identified viewsheds, with particular consideration for their respective abilities to allow the public, VA staff, and patients to appreciate the distinctive qualities of the SFVAMC in its environment. Any proposal to construct a building, structure, landscape element or any other type of feature in a viewshed should consider its potential effect on significant views, and should attempt to avoid or minimize such impacts. As required by Sections 106 and 110 of the NHPA, any such proposal should be developed in close consultation with stakeholders and other consulting parties.

- Roof forms should be flat, reflecting the roofs on contributing buildings within the district.
- Parapets should conceal the roofing material from view from the ground level.
- Mechanical structures should be enclosed in penthouses or shielded from view where feasible. However, penthouses should be made minimally visible within any of the significant viewsheds of the historic district illustrated in *Figure 13*.

- Mechanical systems and rooftop appurtenances on new buildings should be designed to be minimally visible from the main public circulation routes or from any of the significant viewpoints depicted in *Figures 13* and *14* earlier in this report. For NPS guidance on visibility of rooftop additions, refer to *Preservation Brief 14: New Exterior Additions to Historic Buildings: Preservation Concerns in Appendix F*.

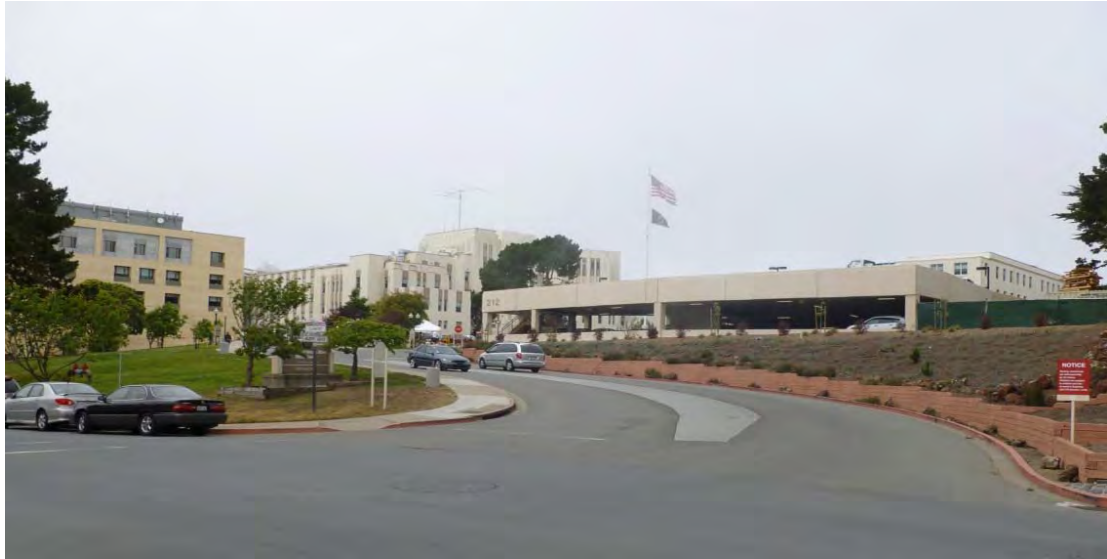
Figure 15. View of campus from Clement Street, facing northwest (photo by HHM, 2014).

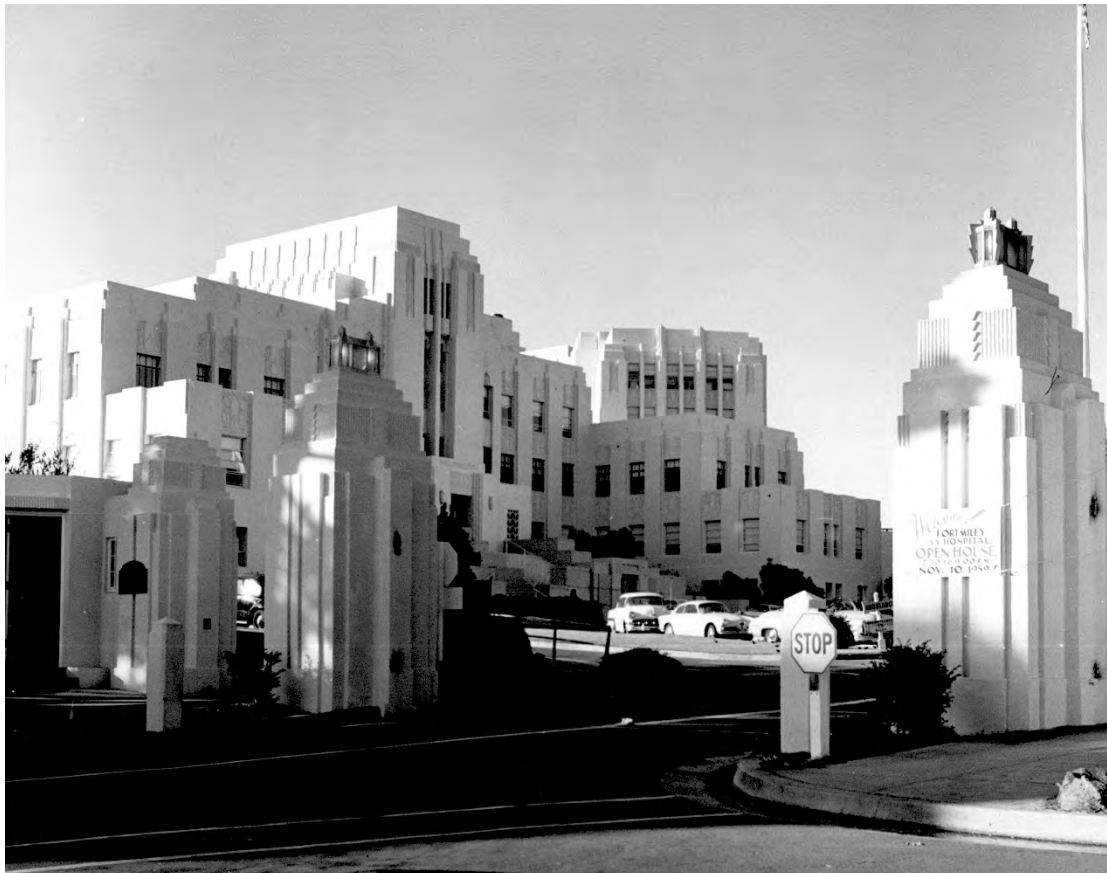
Figure 16. Photograph of the original main entrance gate, located just northwest of the viewpoint at Clement Street and 42nd Avenue, 1959 (courtesy of SFVAMC San Francisco).

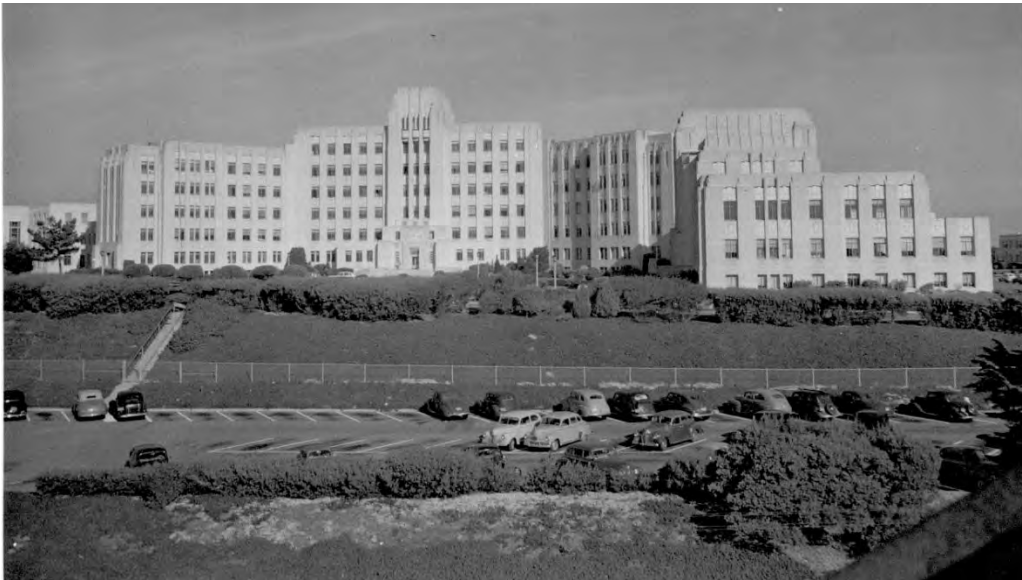
*Figure 18. Photograph of the view from Clement Street at 44th Avenue looking north toward Building 2, 1940s (courtesy of SFVAMC San Francisco).*

The view toward the campus from Clement Street at 44<sup>th</sup> Avenue continues to look onto a steep landscaped buffer along the sidewalk planted with trees. Historically, a grand vista toward the original main hospital building—Building 2—could be seen from this point (see *Figure 18*). Today, Buildings 203 and 200 completely obscure this historic view (*Figure 19*). The existing lawn and steep slope create a buffer between the VA campus and the adjoining residential neighborhood, functioning as transition zone between the two starkly different areas. However, because non-historic buildings block this once impressive view, the viewshed has been completely compromised. Any proposed new construction would have limited potential to affect any of the unique qualities of the SFVAMC Historic District from this location. The viewshed beyond the buffer lacks integrity and therefore does not need to be preserved.

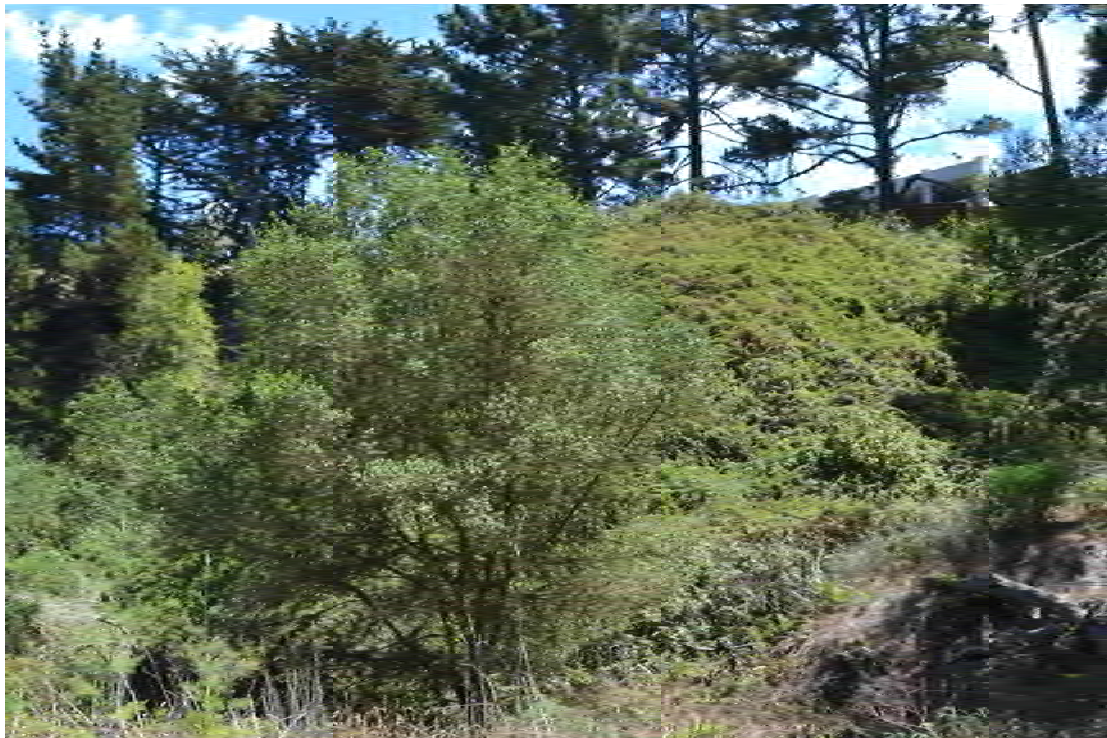
*Figure 21. View of campus northern trail, facing southeast (photo by HHM, 2014).*

From viewpoint No. 5, the steep topography and dense vegetation obscure the visibility of the historic buildings on the campus (see *Figure 21*). Historic photographs from the 1940s and 1950s show that this area was less vegetated at that time. The vegetation present today on NPS land and the steep angle of the bluff largely screen any views of the historic campus from below. Factors such as scale, materials, and placement of any proposed new construction would determine whether proposed buildings or structures to be constructed within this viewshed would detract from the historic character of the SFVAMC Historic District. Given that SFVAMC buildings themselves historically had outward distant viewsheds, it may be appropriate for new construction to be visible from this viewpoint, provided that the style and architectural detailing of new buildings do not overwhelm the natural setting. (Refer to the sections below entitled *Viewsheds* for discussion of views from buildings and *Ensure Compatibility with Existing Historic Architecture* for discussion of scale and architectural detailing, beginning on page 39.)

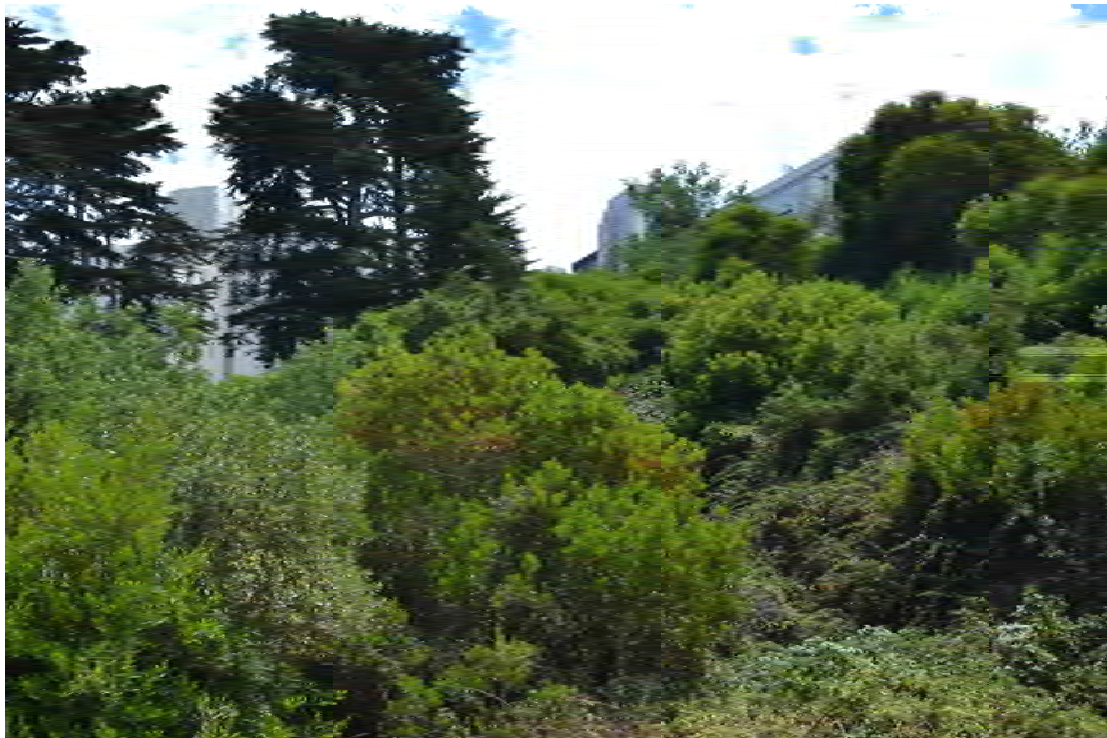
From the Coastal Trail north of Building 6, the architectural detailing above the third floors of Building 6 and Building 2 is visible beyond the densely vegetated bluff (see *Figure 22* below). Based on an analysis of available historic photographs, this area has been densely vegetated throughout the history of SFVAMC, and the current view from this vantage point likely resembles the historic view. Since the topography of the bluff further limits the view of the campus and most of the historic buildings, the significance of this vantage point rests solely on the viewer's ability to see the top portions of Building 2 and Building 6. No new construction within this viewshed should be permitted to obscure the visibility of the north façade of Building 6 or the penthouse of Building 2.

*Figure 22. View of campus northern trail, facing south (photo by HHM, 2014).*

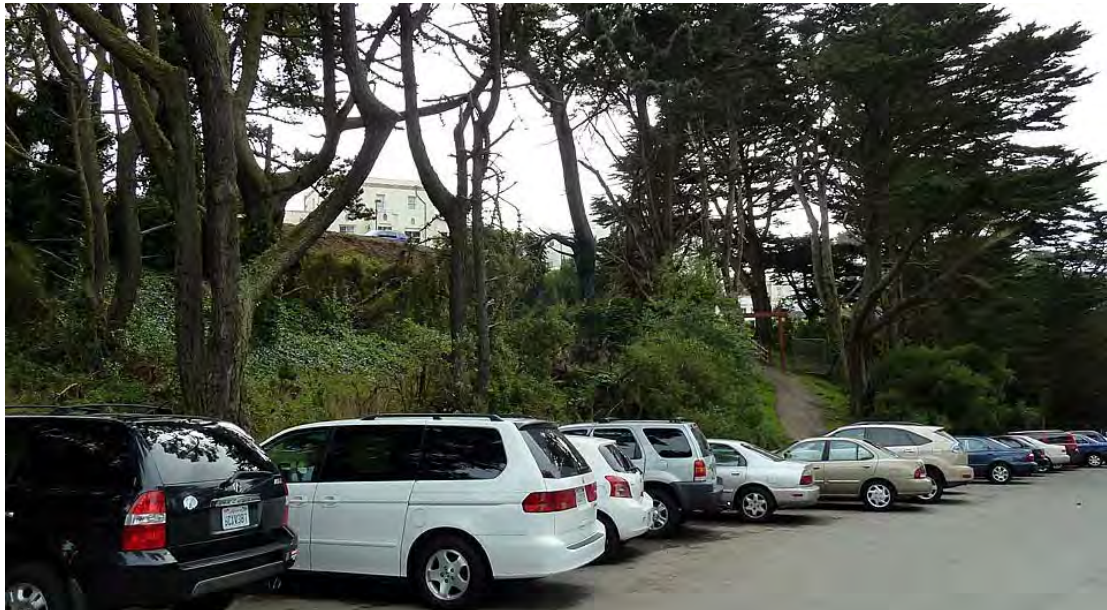
Viewpoint No. 8 is located in a parking lot at the entrance to the Coastal Trail of the GGNRA. At the time of the construction of SFVAMC, this area was a parking lot that served the SFVAMC and East Fort Miley. Today, a narrow break in the vegetation at Viewpoint No. 8 offers a view of Building 11 framed by trees (see *Figure 24* below). The parking lot is an important staging area for the public to walk along the Coastal Trail, but provides only a limited view into the SFVAMC Historic District. In addition, the natural character of this viewpoint is undermined by its use as a parking lot. New construction within this viewshed would be appropriate, provided that the scale and architectural detailing of any new buildings do not overwhelm the natural setting. Critical design issues and concerns from this vantage point include the scale, materials, and detailing of any proposed new construction. (Refer to the section below entitled *Ensure Compatibility with Existing Historic Architecture* for discussion of scale and architectural detailing.)

*Figure 24. View of campus northern trail, facing southwest (photo by HHM, 2014).*

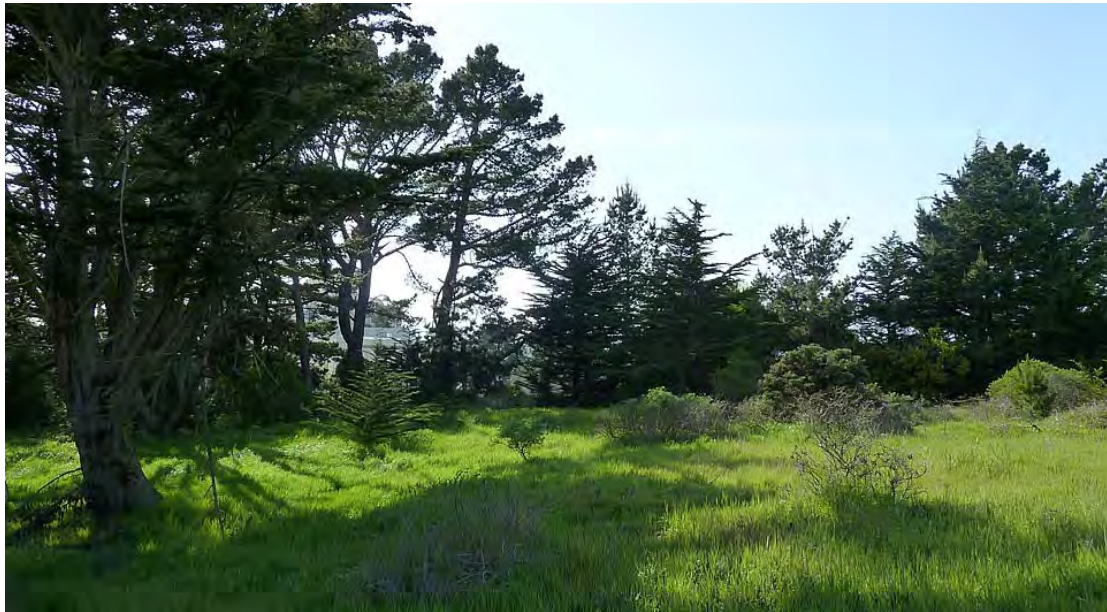
Along the trail through East Fort Miley, glancing views of the top of Building 2 and the Flagpole can be seen through the trees, but topography and vegetation block views of the rear façades of Buildings 8, 9, 10, and 20 along the eastern limits of the campus (see *Figure 25* below). Based on analysis of historic photographs, during the first few decades of the history of the SFVAMC, vegetation appears to have been sparse in this location, but views of Buildings 8, 9, 10, and 20 likely were minimal because of the topography.

*Figure 25. View of campus from east Fort Miley, facing west (photo by HHM, 2014).*

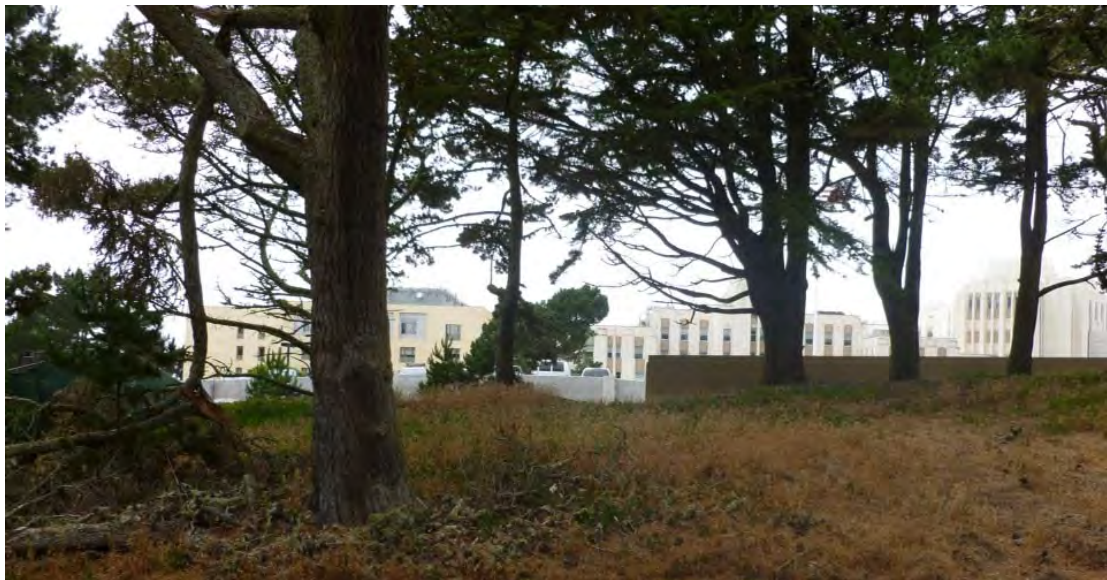
The slight rise in topography at this vantage point provides a clear view of Building 1, Building 2, and the Flagpole. Historically this vantage point had a largely unobscured view of the campus; however, the construction of a non-historic parking garage (Building 212) disrupts the view (see *Figure 26*). Despite this change, the upper floors of Buildings 1 and 2 and the Flagpole remain visible from this location and still enable the public, VA staff, and patients the opportunity to see and appreciate the historic character of the SFVAMC Historic District. Critical design issues and concerns from this vantage point include the scale, materials, and detailing of any proposed new construction. New construction within this viewshed should not further obstruct the visibility of Building 1, Building 2, or the Flagpole.

*Figure 26. View of campus from east Fort Miley, facing west (photo by HHM, 2014).*
