# San Francisco Veterans Affairs Medical Center *Historic District Design Guidelines*

August 2015

U.S. Department of Veterans Affairs, Office of Construction and  
Facilities Management, Washington, D.C.

Contract No. VA101CFM-P-0096  
Task Order VACFM05-0018

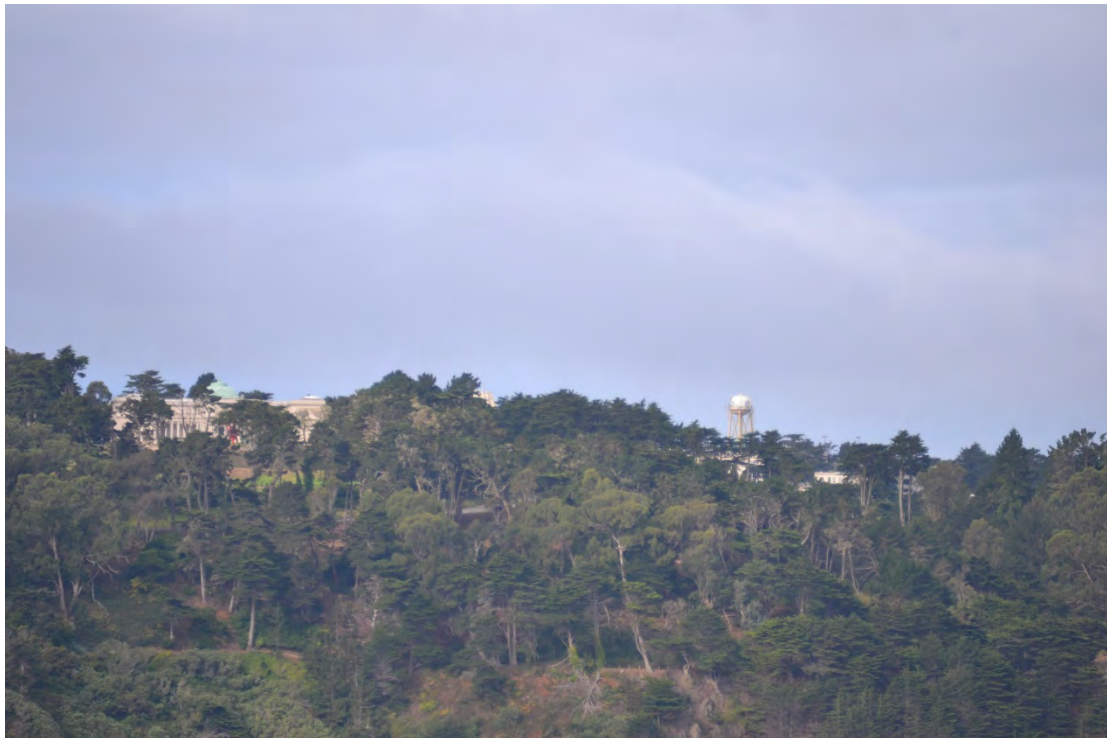
This vantage point looks onto the SFVAMC campus from the Presidio looking west across the water. From this distance, the only clearly visible structures at the campus are the tops of Building 2 and the non-historic water tower, both of which rise above the tree line and dense vegetation. Buildings 6 and 18 also can be seen at gaps between the trees (see *Figure 28*). The overall character of this view is natural, with manmade elements receding behind the majestic view of water, bluffs, and trees. With the passage of time and growth of vegetation on NPS lands that formerly were part of Fort Miley, most of the SFVAMC campus can no longer be seen from this vantage point, and the relative lack of man-made elements visible from this location contributes to the natural and scenic beauty of the GGNRA that contrasts to the highly developed urban landscape surrounding the park and SFVAMC. The existing tree line as seen from this viewshed is a distinctive attribute that has attained significance as vegetation within the GGNRA has been allowed to grow. The tree line today is about 70 feet above the ground surface; however, this line can be expected to change as trees grow and are removed, so the height of any new construction within this viewshed should be kept below about 70 feet. Critical design issues and concerns from this vantage point include the scale, materials, and detailing of any proposed new construction, especially anything that rises above the height of whatever vegetative screen exists at the time such construction is planned. (Refer to the detailed discussion of building height under the heading *Ensure Compatibility with Existing Historic Architecture* below.)

*Figure 28. View of campus from the Presidio, facing southwest (photo by HHM, 2014).*

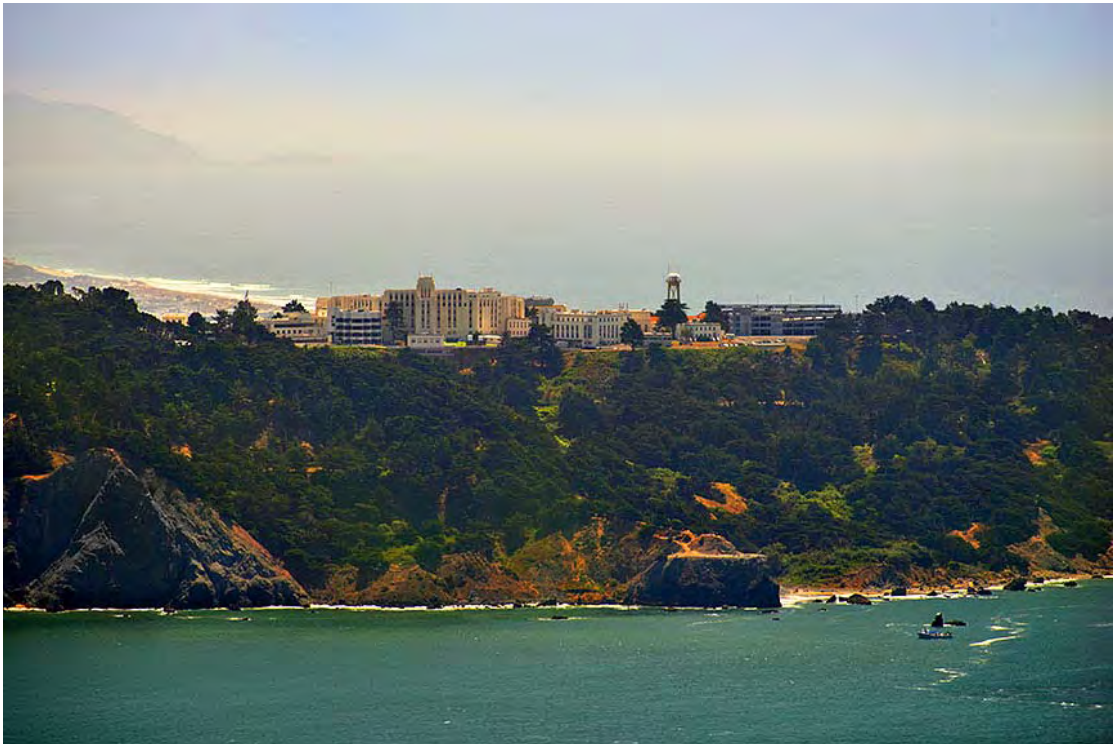
Like the view from the Presidio, the overall character of the view from the Marin Headlands highlights the natural setting of the GGNRA (see *Figure 29*). Building 2 and the non-historic water tower are prominently visible. Because of elevation differences, most of the campus' north-facing façades are visible from the Headlands, though of course they are much more distant from the viewer.

As with the view from the Presidio, if new buildings are constructed within this viewshed, they should not rise at any point above approximately 70 feet above the ground, roughly equivalent to the current tree line. Critical design issues and concerns from this vantage point include the scale, materials, and detailing of any proposed new construction. (Refer to the detailed discussion of building height under the heading *Ensure Compatibility with Existing Historic Architecture* below.)

*Figure 29. View of campus from the Marin Headlands, facing south (photo by Scott Hess. 2015).*

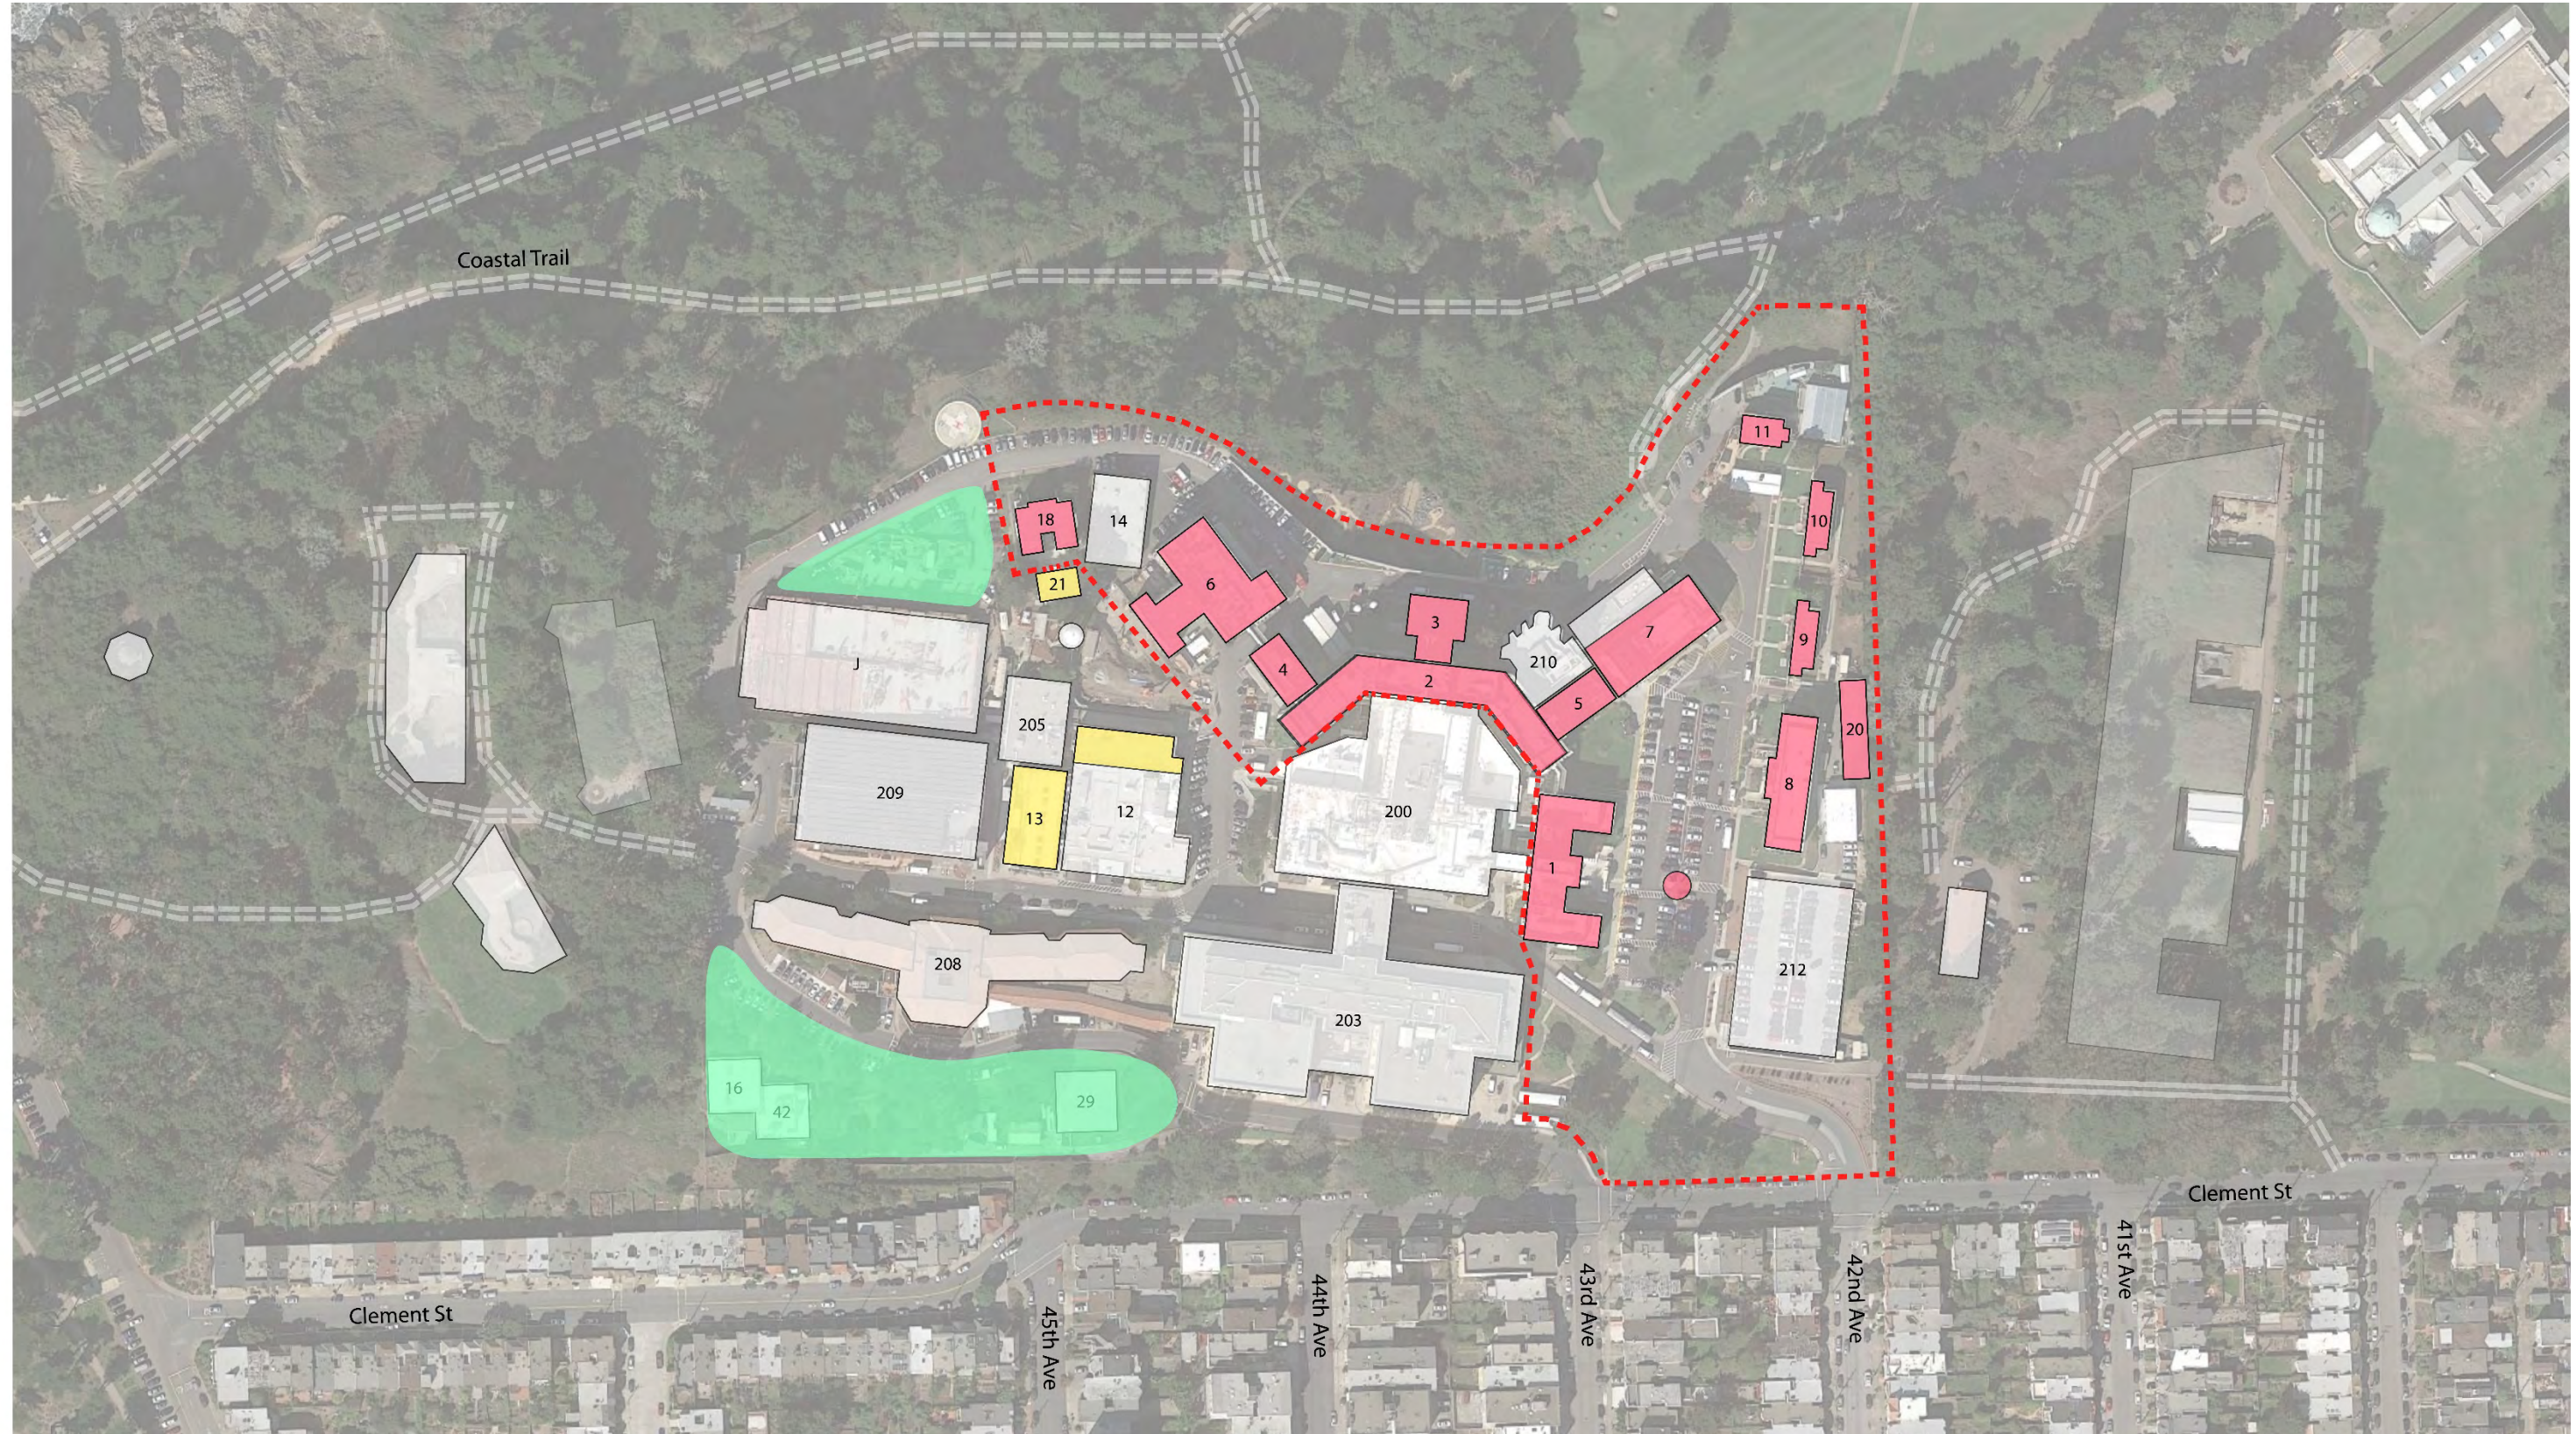
Figure 33. Site plan depicting the SFVAMC Historic District boundaries and contributing buildings in red, other historic 1934 buildings in yellow, and preferred areas for new construction in green.

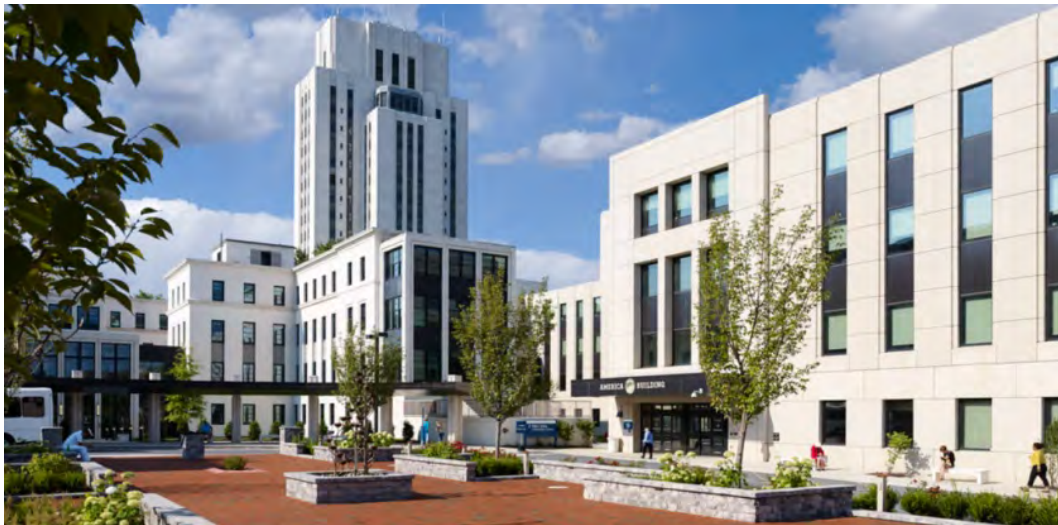
*Figure 36. Note how the color, massing, and verticality of the fenestration pattern of the new building on the right all reflect the design of the original historic buildings at the center and yet do not detract from them. National Naval Medical Center at the Walter Reed Military Medical Center in Bethesda, Maryland, designed by HOK, 2012, <http://www.hok.com/design/type/healthcare/walter-reed-national-military-medical-center/> (accessed August 24, 2014).*

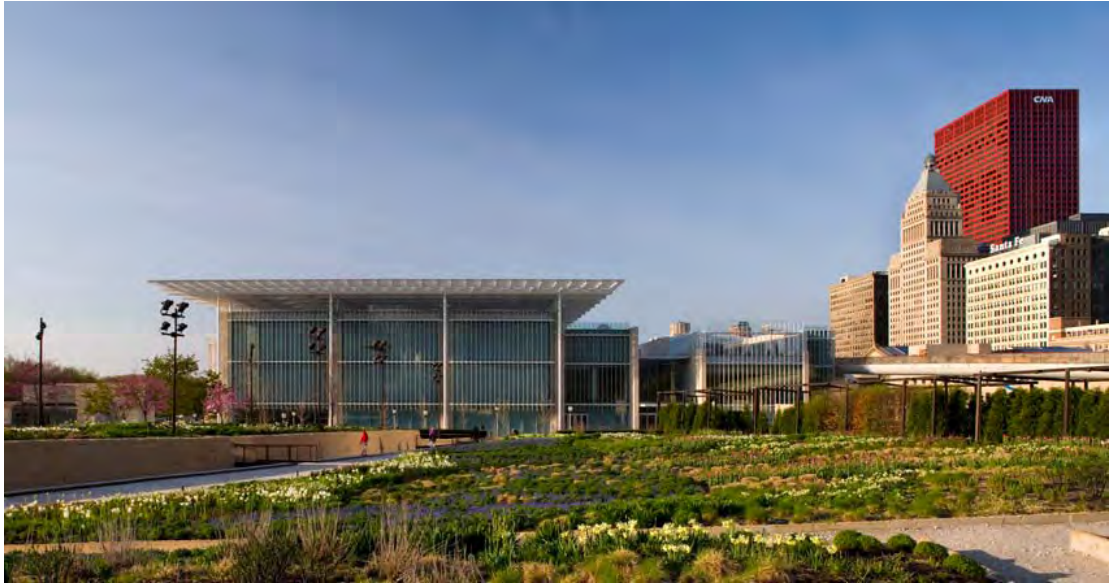
Figure 37. Although the exterior walls of the new building are primarily glass, the color palette complements the materials of the surrounding historic buildings. Modern Wing at the Chicago Art Institute, designed by the Renzo Piano Building Workshop, Chicago, Illinois, 2009, [http://www.archdaily.com/24652/the-modern-wing-renzo-piano/262826382\\_t-m-w-1/](http://www.archdaily.com/24652/the-modern-wing-renzo-piano/262826382_t-m-w-1/) (accessed August 24, 2014).

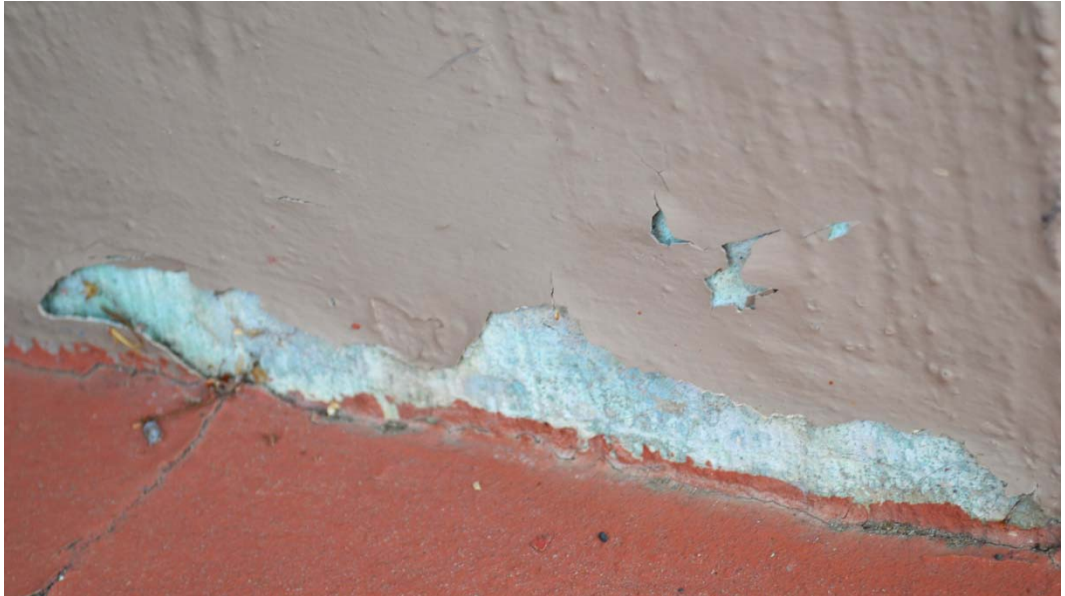
*Figure 38. Detail of paint peeling from stucco in a typical exterior entryway (photo by HHM, 2014).*

- Retain original walls (*Figure 38*). Repair damaged exterior wall materials to the greatest extent possible. Replace only those sections that are deteriorated beyond repair. If repairs are necessary, they should be conducted as set forth in *Preservation Brief 22: The Preservation and Repair of Historic Stucco*, which is included in *Appendix F*.

- Replace deteriorated wall materials in-kind to match existing wall materials.
- When cleaning stucco exterior walls, use the gentlest means possible. Test a small patch to ensure that the cleaning method does not damage the underlying materials. (Refer to the NPS *Preservation Briefs* in *Appendix F*.)

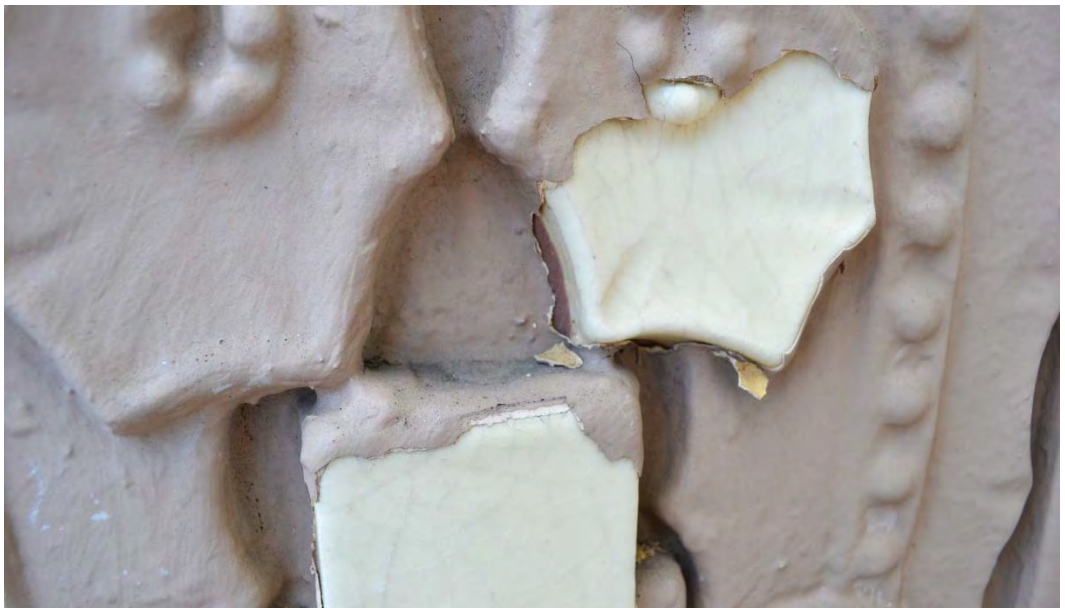
*Figure 39. Detail of original ornamental terra-cotta under peeling paint (photo by HHM, 2014).*

- If considering removing the non-historic paint that currently coats the historic terra cotta elements on the exterior walls, remove it using the gentlest means possible (see *Figures 39 and 40*). Moisture may become trapped between the paint and terra cotta, causing deterioration of the underlying materials. Test a small patch to ensure that the paint removal does not damage the underlying materials. Refer to NPS *Preservation Brief 7* included in *Appendix F* for additional guidance regarding historic terra cotta.

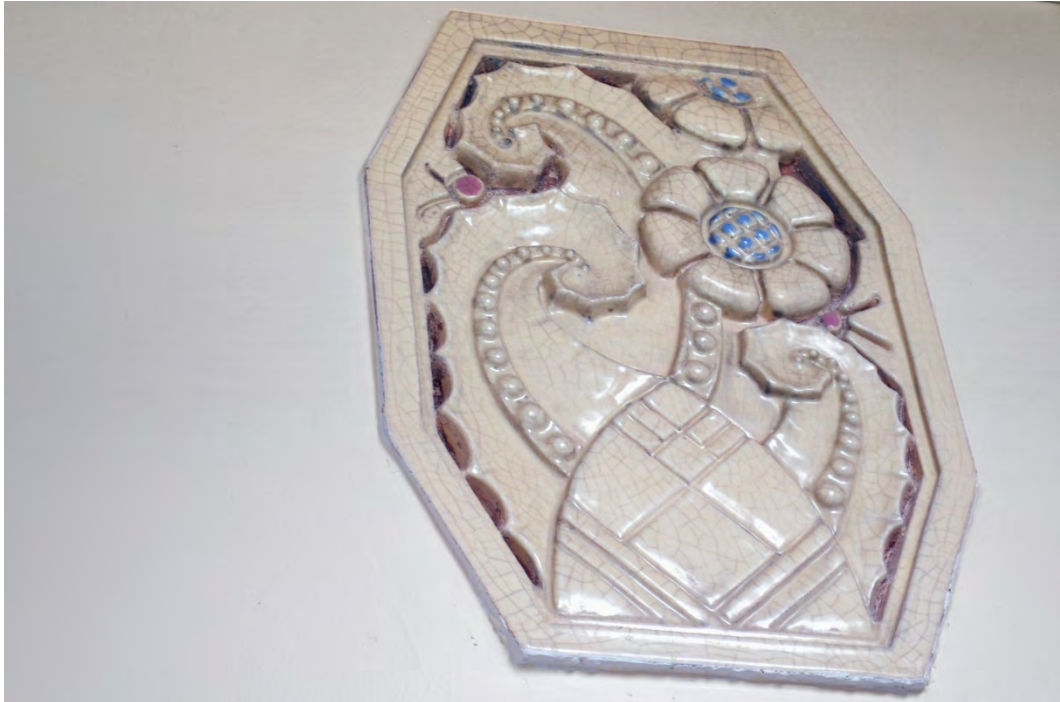
Figure 40. Detail of original unpainted ornamental terra-cotta panel located in Building 11, (photo by HHM, 2014).

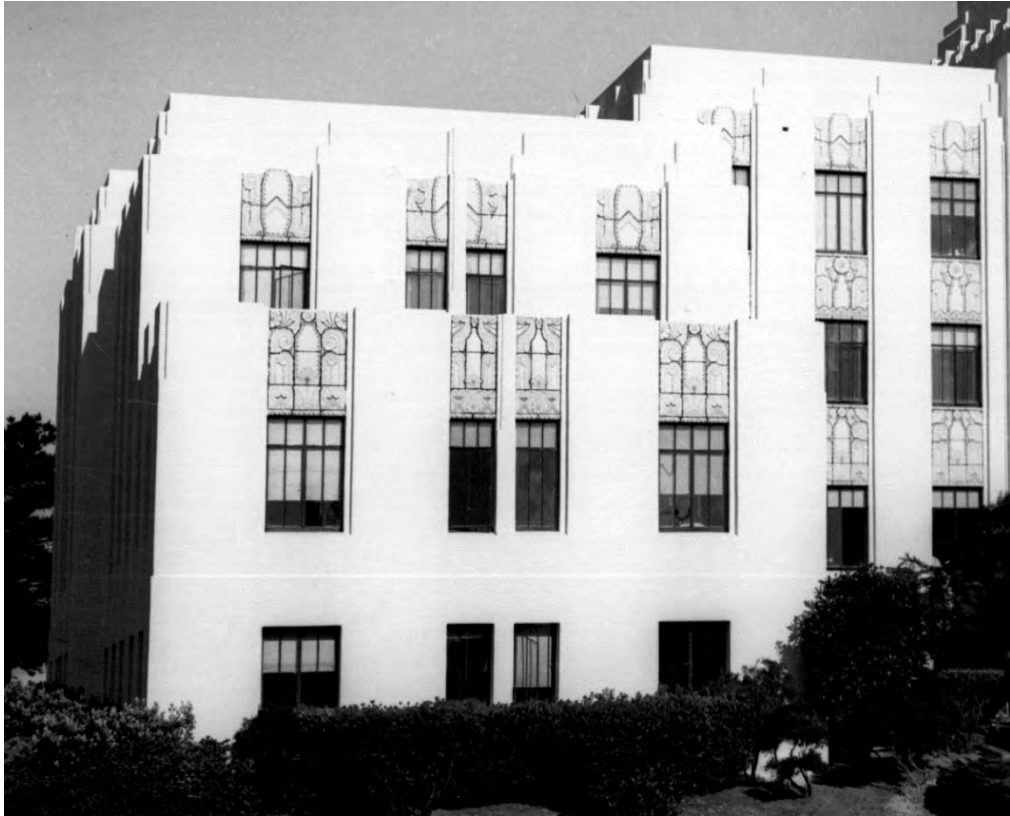
*Figure 41. South wing of Building 1 showing original steel frame casement windows, facing west, ca. 1950 (courtesy of SFVAMC).*

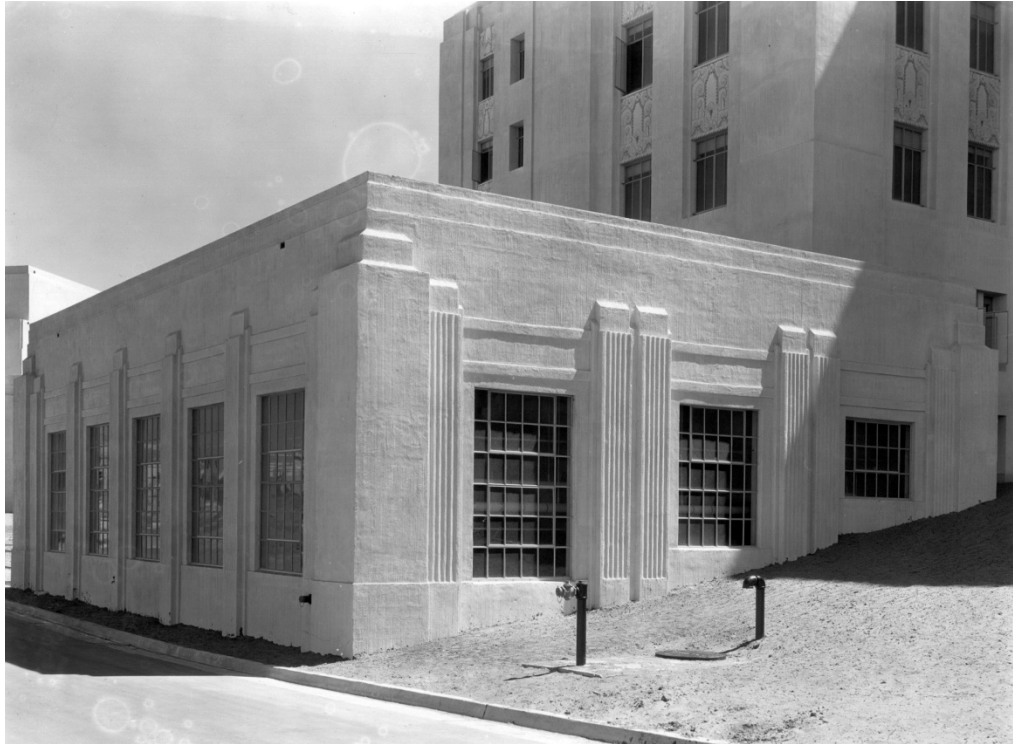
*Figure 42. Building 3 showing original steel frame windows, ca. 1934 (courtesy of SFVAMC).*

- The non-historic windows within the SFVAMC Historic District today generally are compatible with the design and style of the historic buildings and may be maintained in place. (See *Figures 42 through 45* for illustrations of extant windows.) However, non-historic windows should not be replaced with a new replica of the non-historic window; NPS guidance states “if replacement is chosen, the new windows must be based on existing fabric, on historic documentary or pictorial evidence or, they must be compatible with the historic character of the building.”<sup>13</sup> For the SFVAMC Historic District, historic photographs and architectural drawings documenting the appearance of the original windows are available. Additional information is provided in the NPS *Interpreting the Standards Bulletin 23: Selecting New Windows to Replace Non-Historic Windows*, included in *Appendix F*.

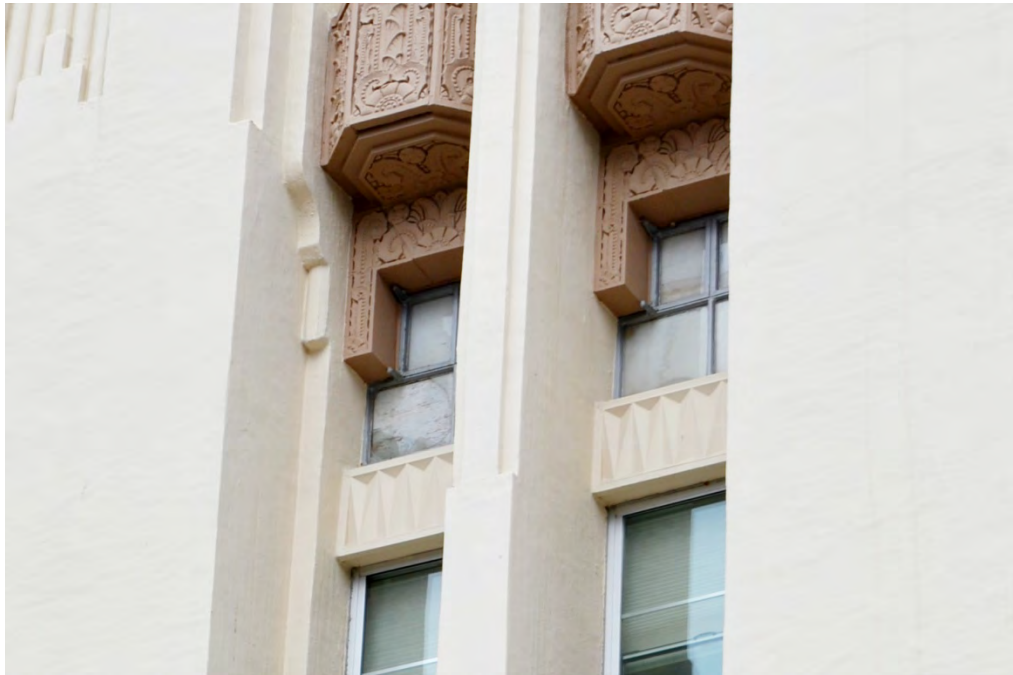
*Figure 43. Detail of windows at the tower on Building 1, showing original steel frame windows above newer, non-historic aluminum frame windows (photo by HHM, 2014).*

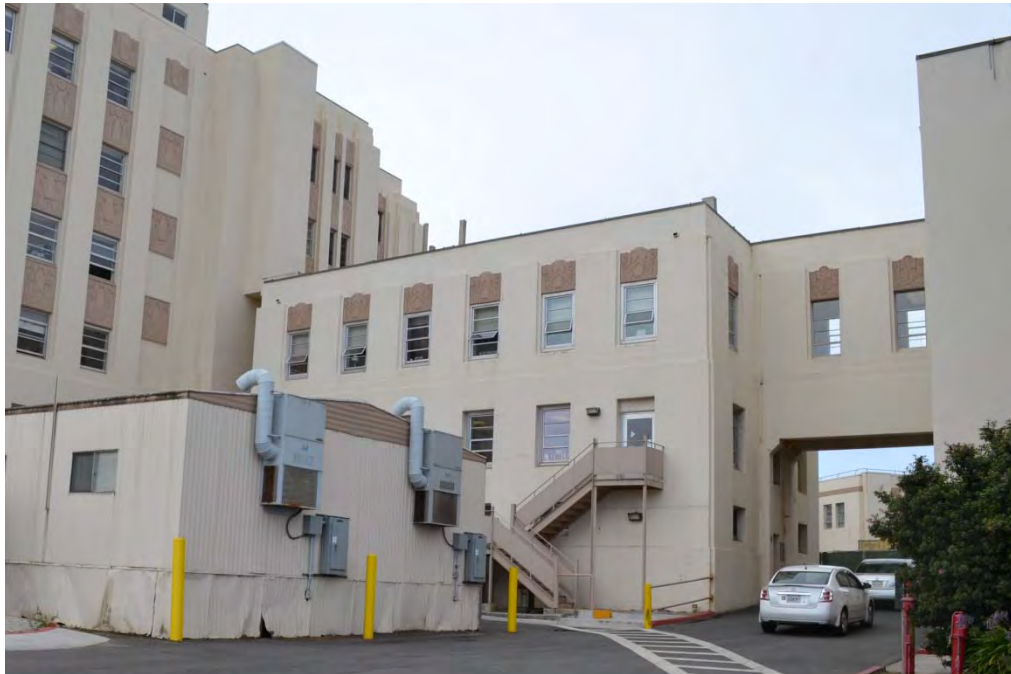
Figure 44. Non-historic aluminum double-hung windows on Building 2 (left) and non-historic aluminum windows on Building 4 (right) (photo by HHM, 2014).

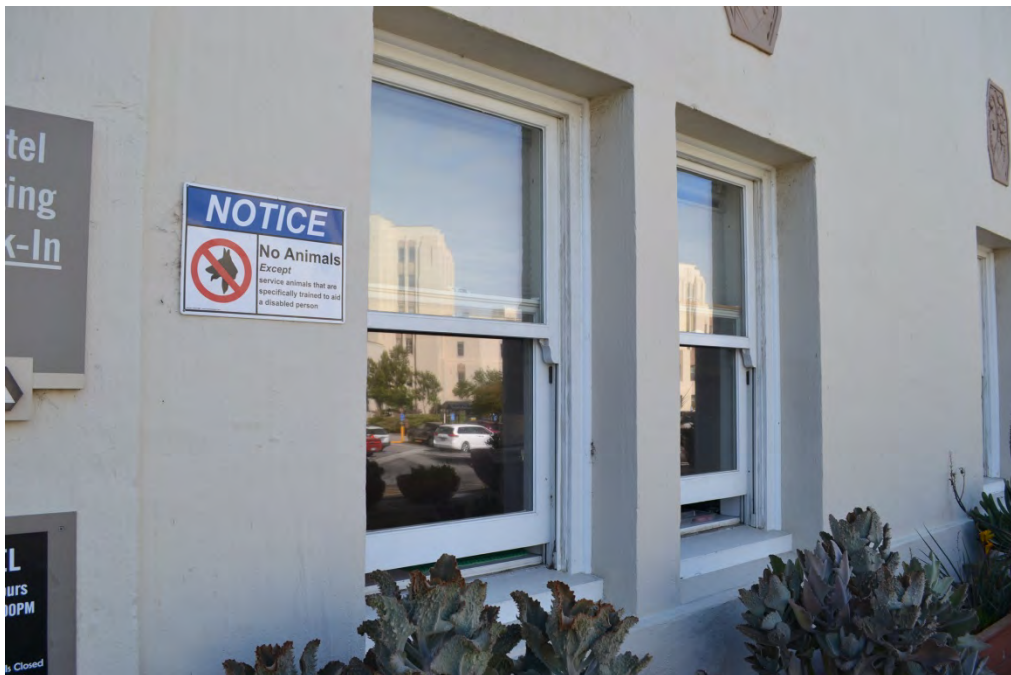
Figure 45. Example of original one-over-one wood-sash windows on Building 9. Historic photographs show that steel casement windows originally were present on Building 9, but the style and construction methods of these windows suggest that they likely date from the 1930s or 1940s. It is unclear whether or not the wood windows were installed during the period of significance (1934–1941), and historic research would be required to determine the exact dates of the windows (photo by HHM, 2014).

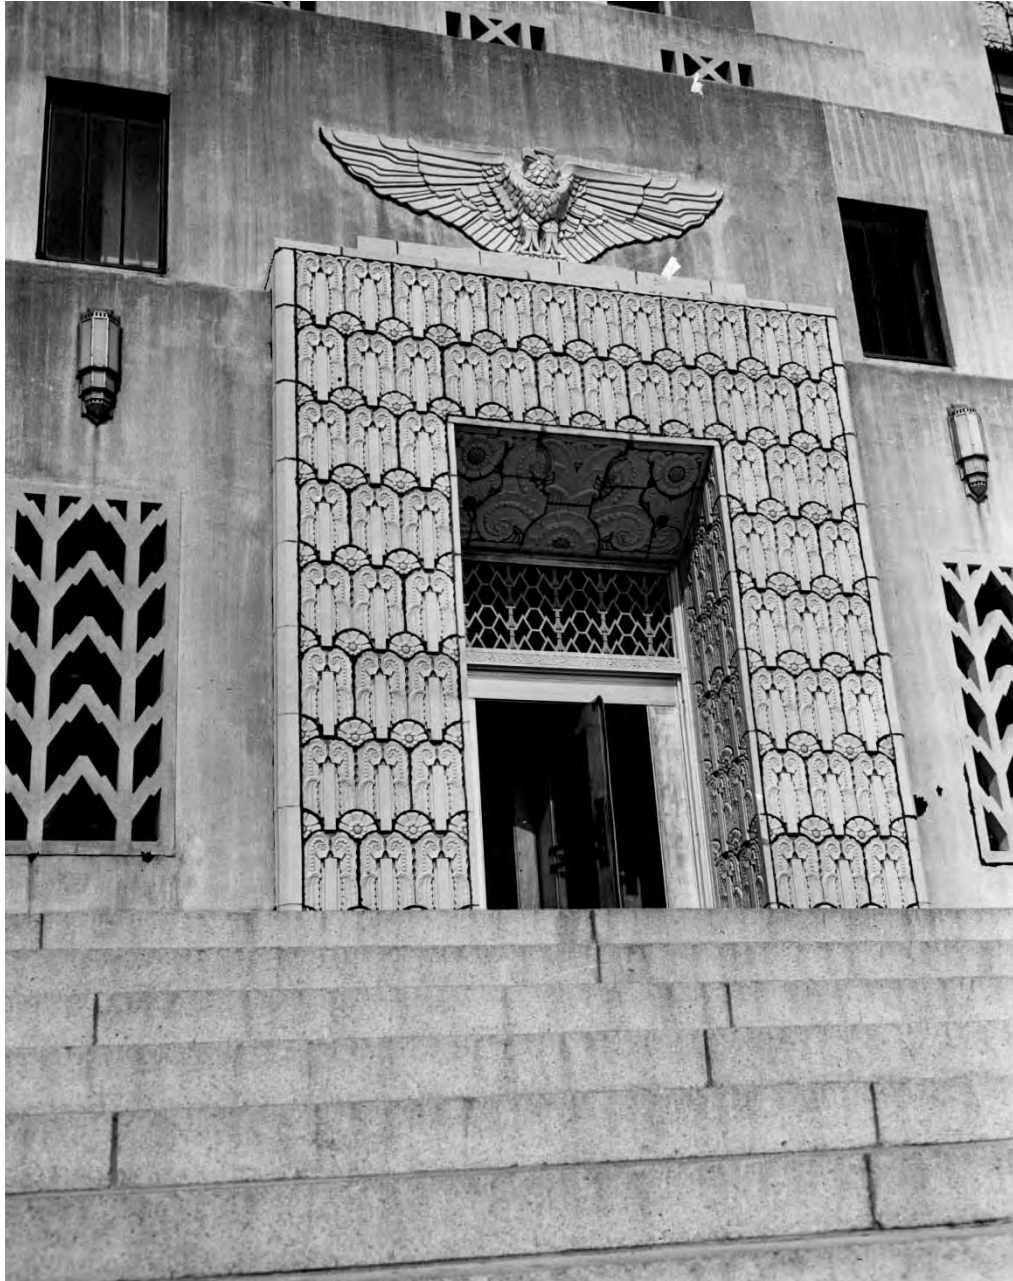
*Figure 48. Photograph of the original entrance of Building 2 in 1939, showing the steel revolving door and decorative steel grate at the transom (courtesy of SFVAMC).*

- Retain and repair historic doors, door surrounds, sidelights, and transoms (see *Figure 48*). Historic photographs taken during and immediately after construction suggest that double doors with inset octagonal panels were present on the campus historically.<sup>16</sup> Similar doors remain intact on Buildings 9, 10, 11, and 18, as illustrated in 2014 photographs in *Appendix G*, and are character-defining features of these buildings.<sup>17</sup> Preservation and repair methods should comply with the appropriate methods for steel or wood set forth in NPS Preservation Briefs Nos. 9 and 13, included in *Appendix F*.

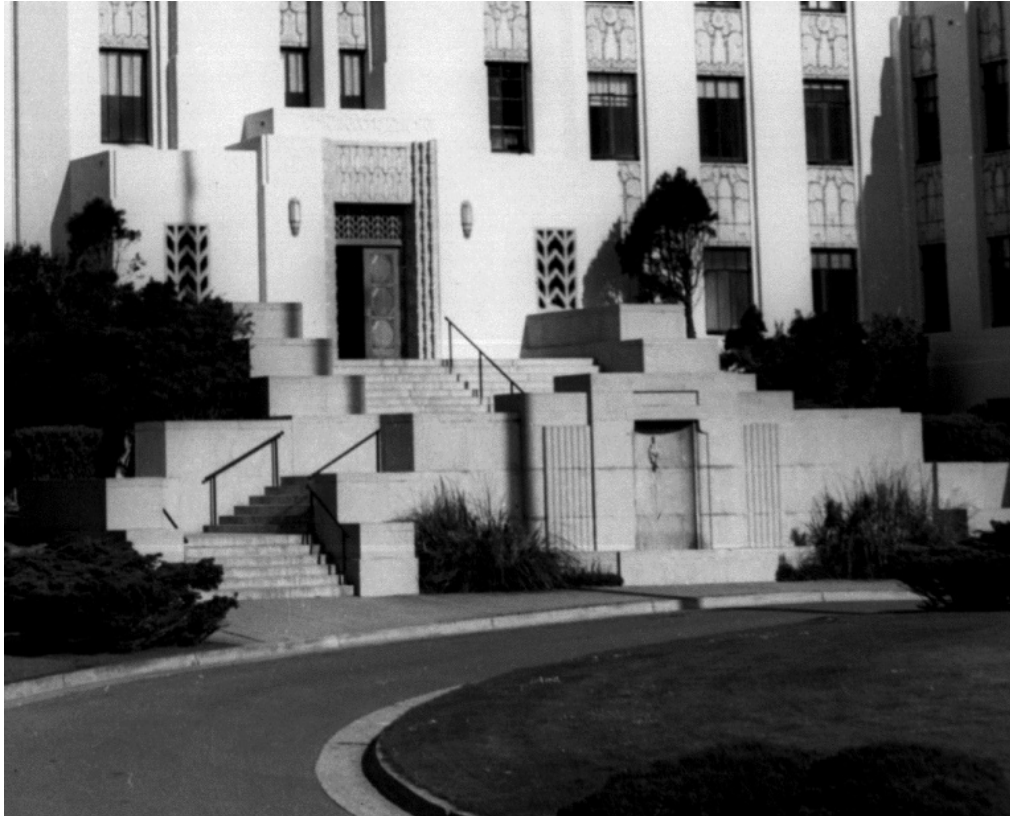
Figure 49. Detail of photograph of Building 1 in the 1950s, showing the double stair at the entrance (courtesy of SFVAMC).

- If the original doors no longer exist, replacement doors should replicate the size, profile, configuration, and finish, as documented by observation of extant historic doors on other buildings historic photos and architectural drawings.
- The main front entrances to historic buildings on the SFVAMC campus all include entrance stoops that are not accessible to people with disabilities. However, these main entrances are the focal point of the historic design and include rich architectural detailing that should be preserved to the greatest extent feasible (see *Figure 49*). Alterations to the building to enhance accessibility should be designed in accordance with NPS *Preservation Brief No. 3: Making Historic Properties Accessible* and *Interpreting the Standards Bulletin 53: Designing New Additions to Provide Accessibility*, which are included in *Appendix F*.

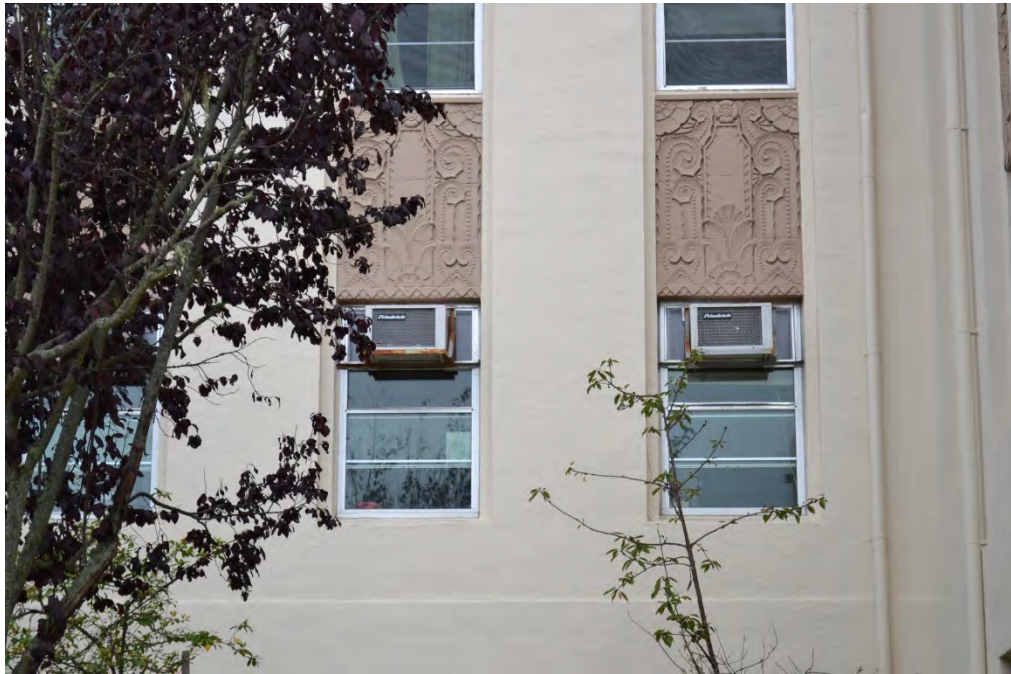
*Figure 50. Photo of non-historic window units installed in the non-historic windows at Building 1 (photo by HHM, 2014).*

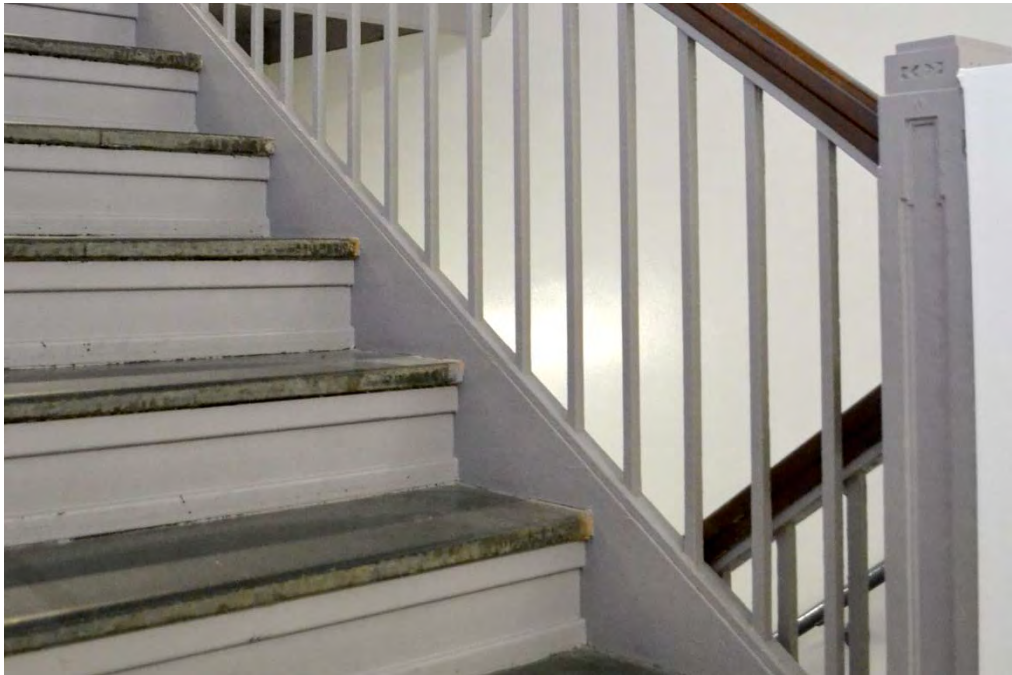
Figure 52. Stairway in Building 1 showing original slate stair treads (photo by HHM, 2014).

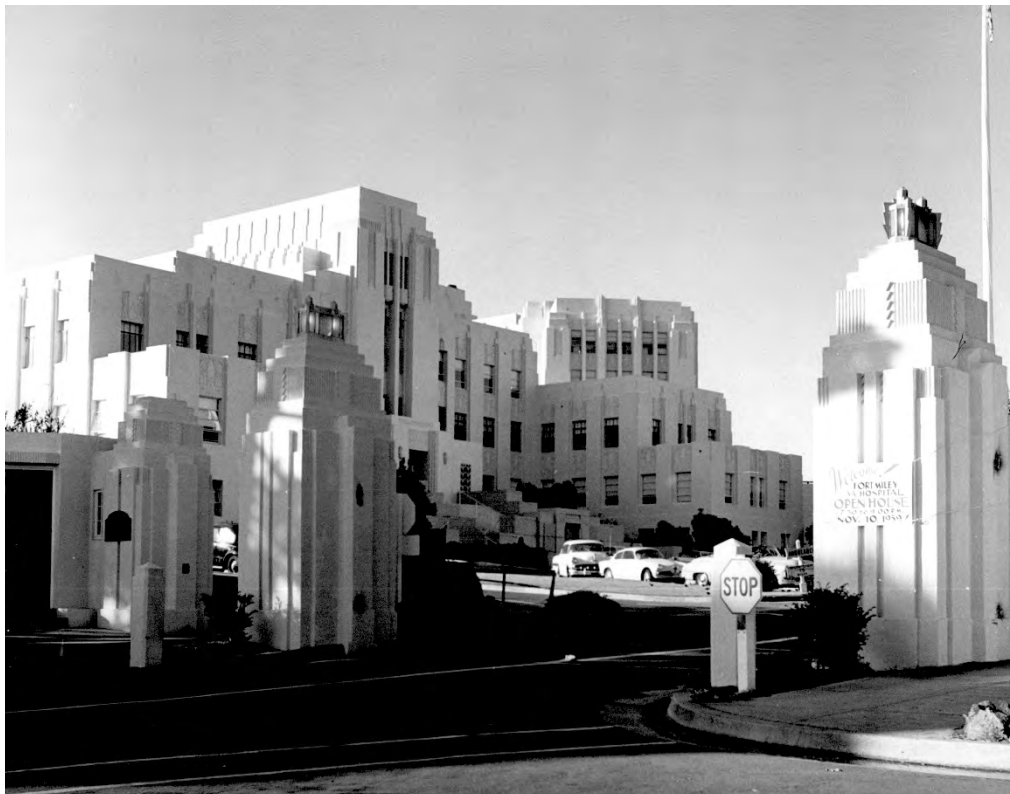
Figure 53. Historic photo showing the original main entrance gate in 1959 (courtesy of SFVAMC).

- The *Secretary's Standards for Rehabilitation* do not require the restoration of lost landscape elements or other historic fabric. However, should the opportunity arise as part of VA's ongoing long-range management of the campus, it would be consistent with the general philosophy of the *Standards* to restore significant missing landscape features, such as the original Art Deco gate that was located at the main entrance and forecourt and circular drive that were located in front of Building 1 (see *Figures 53 and 54*).

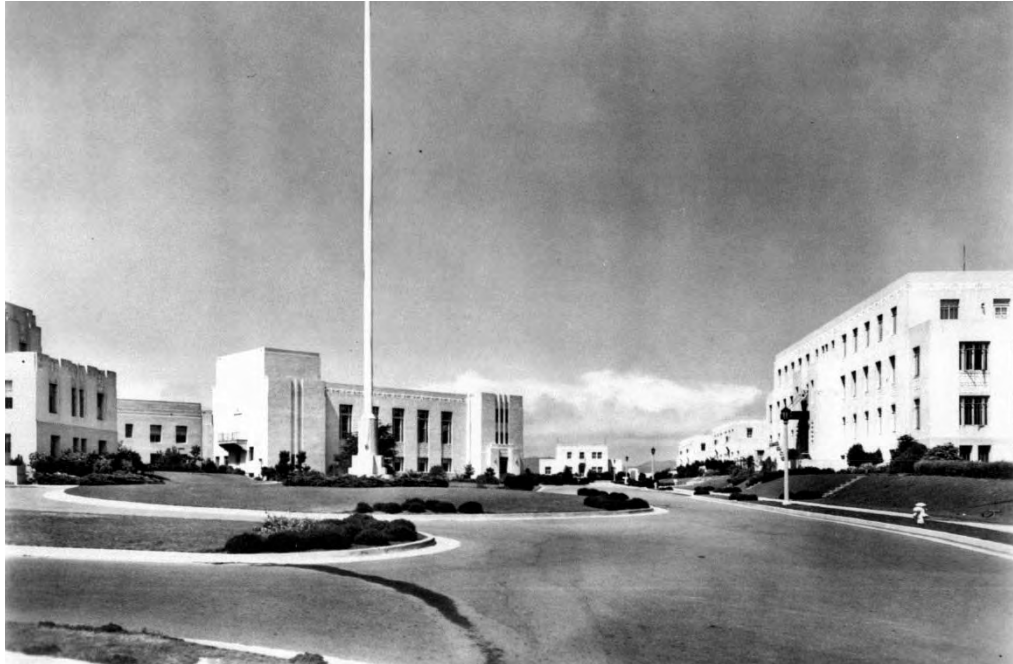
Figure 54. Historic photo showing the original forecourt and flagpole in front of Building 1 in the 1950s (courtesy of SFVAMC).

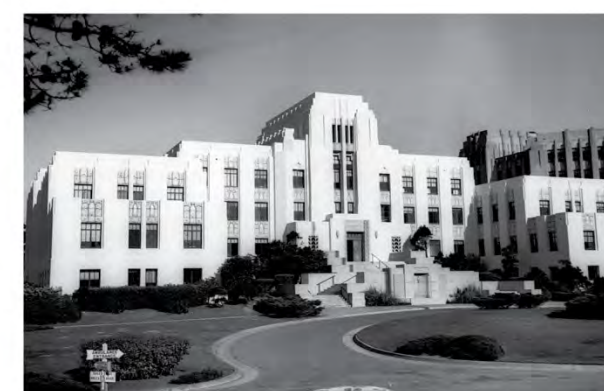
View of Building 1 and landscaped forecourt looking west, c. 1950 . Note the original steel windows and doors and the unpainted terra cotta spandrels. (Courtesy of SFVAMC)

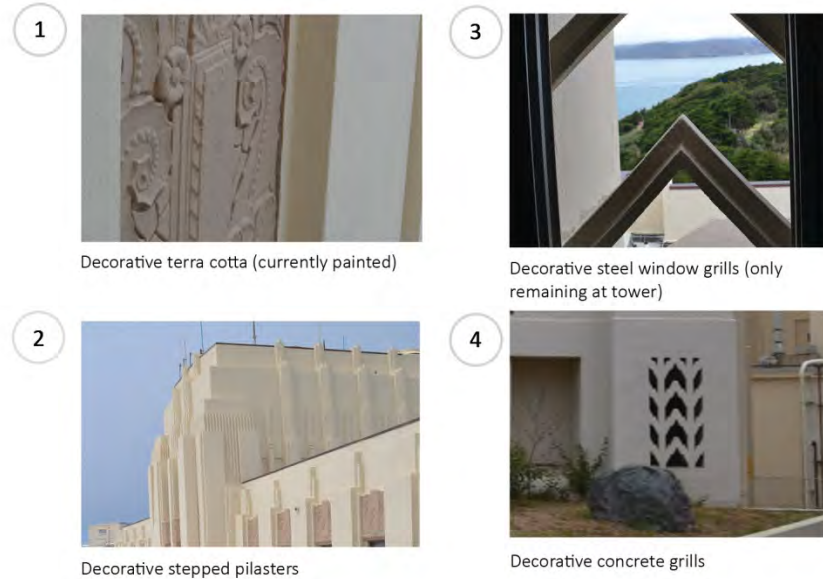
Decorative terra cotta (currently painted)

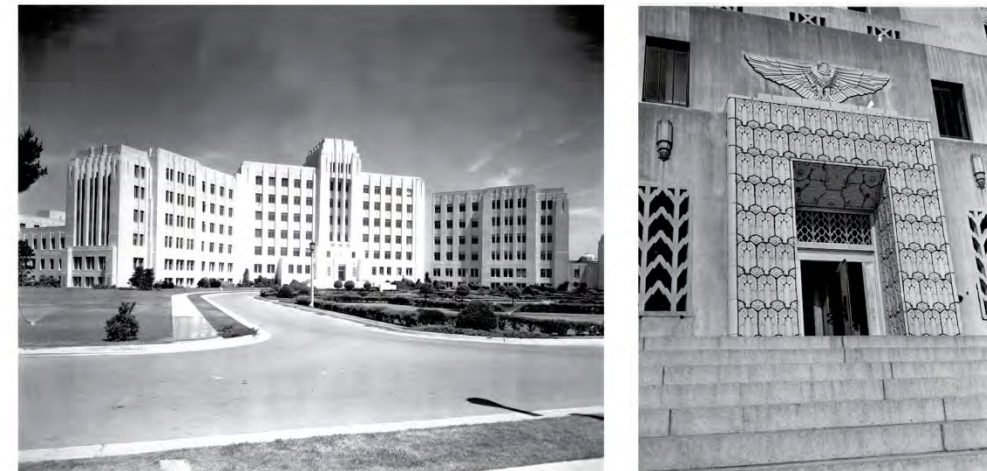
View of Building 2 and landscaped forecourt looking north, c. 1939, prior to additions of Building 200 and 203. (Courtesy of SFVAMC)

View of original entrance of Building 2, c. 1939, prior to addition of Building 200. Terra cotta eagle above door still remains in utility space (Courtesy of SFVAMC)

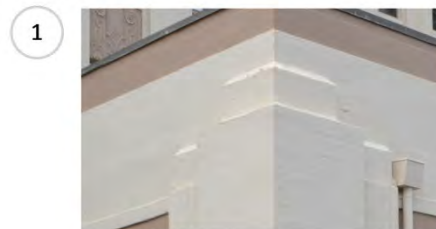
Decorative stepped pilasters

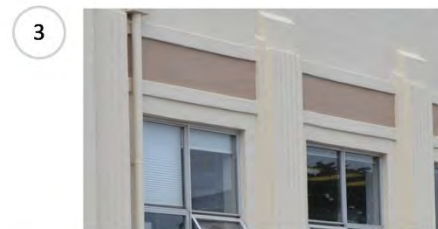
Fluted profile on engaged pilasters between windows

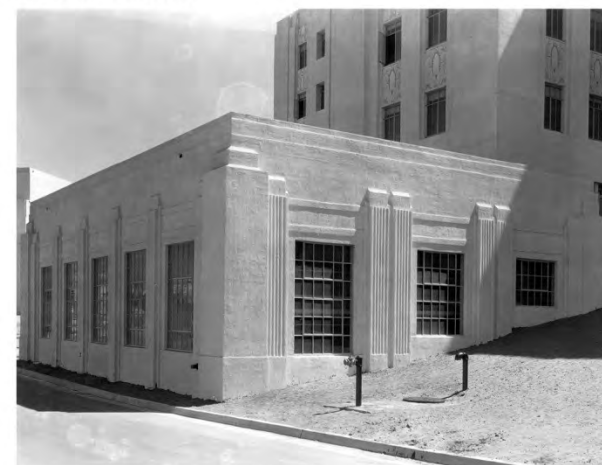
View of Building 3, c. 1934 . Note the original steel windows and larger window openings. (Courtesy of SFVAMC)

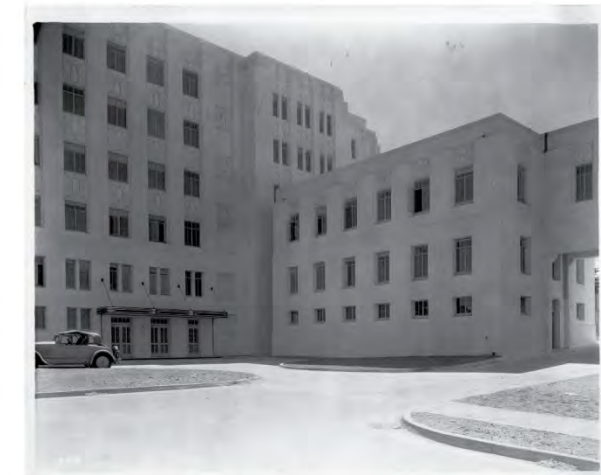
View of Building 4, c. 1934 . Note the original steel casement windows and the unpainted terra cotta spandrels. (Courtesy of SFVAMC)

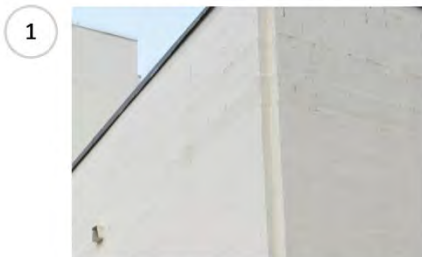
Painted stucco on concrete exterior walls

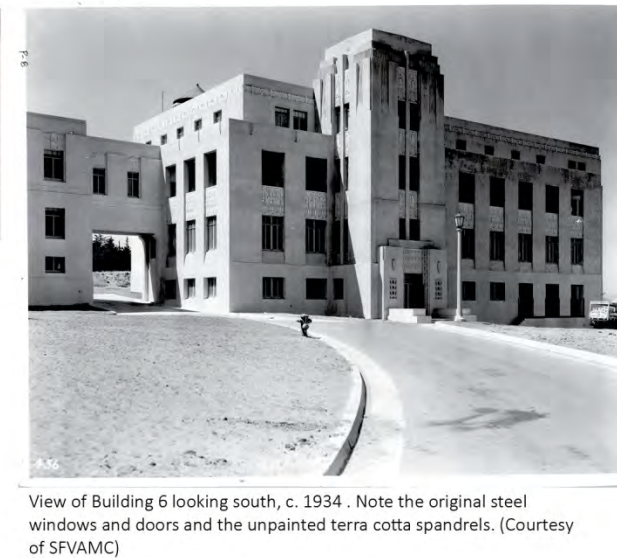
Figure 60. Character-defining features of Building 6. (Current photos by HHM, 2014; historic photos courtesy of SFVAMC..)

View of Building 6 looking south, c. 1934 . Note the original steel windows and doors and the unpainted terra cotta spandrels. (Courtesy of SFVAMC)

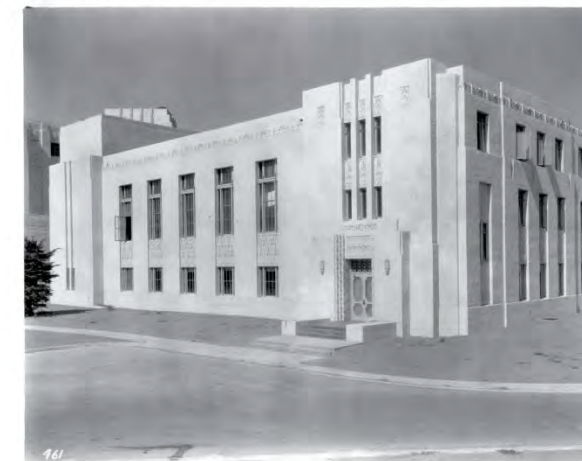
Figure 61. Character-defining features of Building 7. (Current photos by HHM, 2014; historic photos courtesy of SFVAMC..)

View of Building 7 looking northwest, c. 1934 . Note the original steel windows and doors and the unpainted terra cotta spandrels. (Courtesy of SFVAMC)
