# San Francisco Veterans Affairs Medical Center *Historic District Design Guidelines*

August 2015

U.S. Department of Veterans Affairs, Office of Construction and  
Facilities Management, Washington, D.C.

Contract No. VA101CFM-P-0096  
Task Order VACFM05-0018

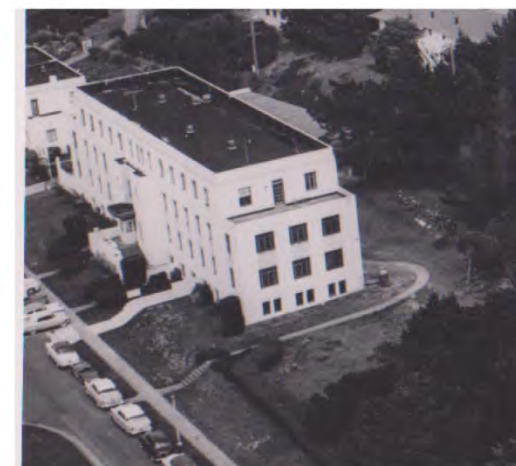
Figure 62. Character-defining features of Building 8. (Current photos by HHM, 2014; historic photos courtesy of SFVAMC..)

View of Building 8 looking north, c. 1950 . Note the original steel windows, unpainted terra cotta spandrels, and lack of 3rd floor additions on each stepped side wing. (Courtesy of SFVAMC)

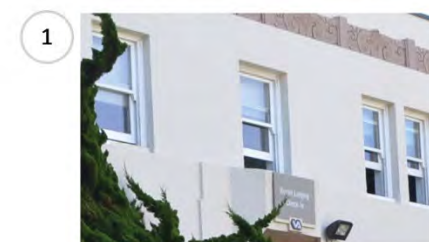
Historic-age wood double-hung windows

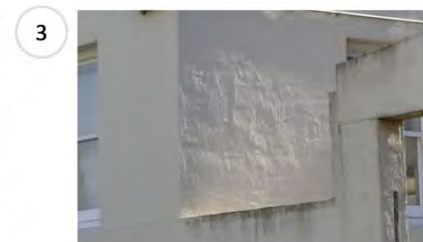
Painted stucco on concrete exterior walls

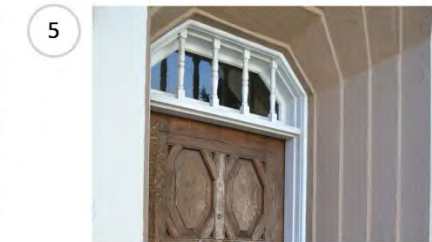
Decorative wood doors, transom, stepped concrete arches at door surround

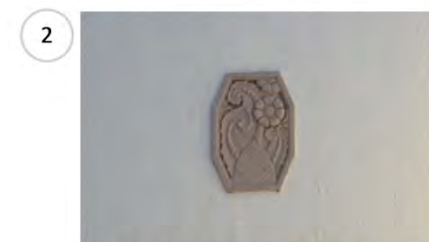
Decorative terra cotta (currently painted)

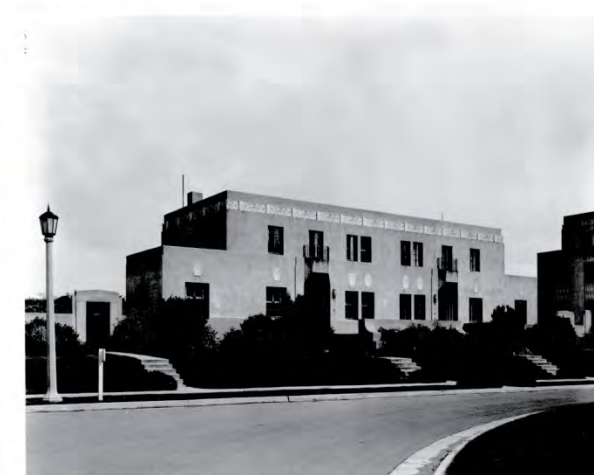
View of Building 9 looking east, c. 1934. Note the original steel windows and the unpainted terra cotta spandrels. (Courtesy of SFVAMC)

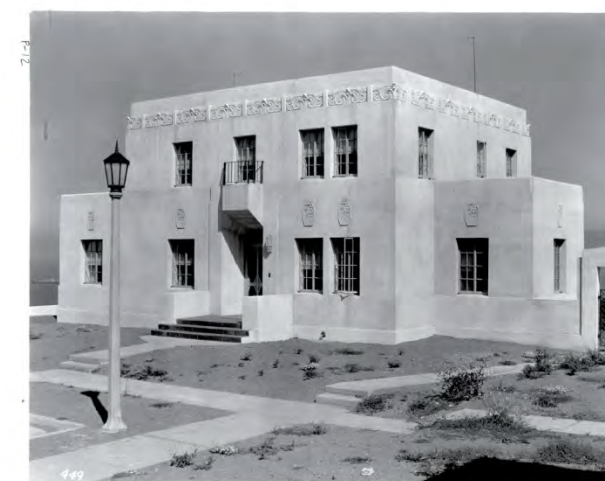
Figure 65. Character-defining features of Building 11. (Current photos by HHM, 2014; historic photos courtesy of SFVAMC..)

View of Building 11 looking north, c. 1934 . Note the original steel windows and the unpainted terra cotta features. (Courtesy of SFVAMC)

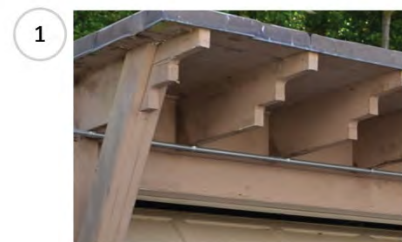
Decorative wood brackets

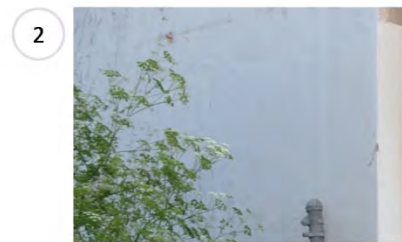
Painted stucco on concrete exterior walls

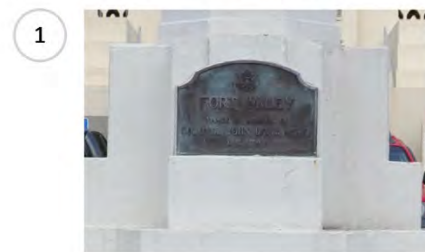
Bronze plaque

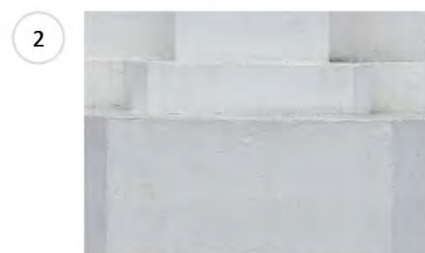
Painted stucco on concrete exterior walls

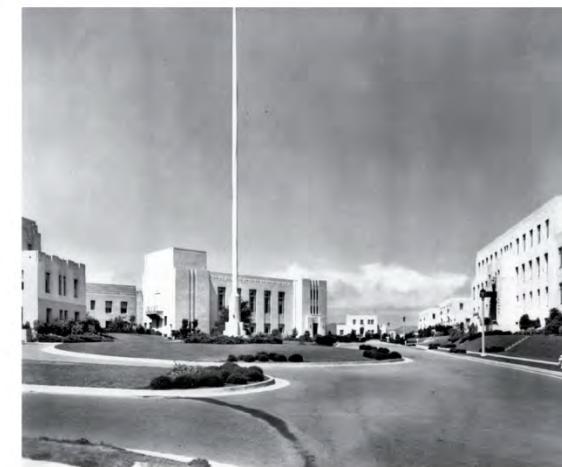
Figure 68. Character-defining features of the Flagpole. (Current photos by HHM, 2014; historic photos courtesy of SFVAMC..)

View of flagpole and landscaped forecourt looking north, c. 1950.  
 (Courtesy of SFVAMC)

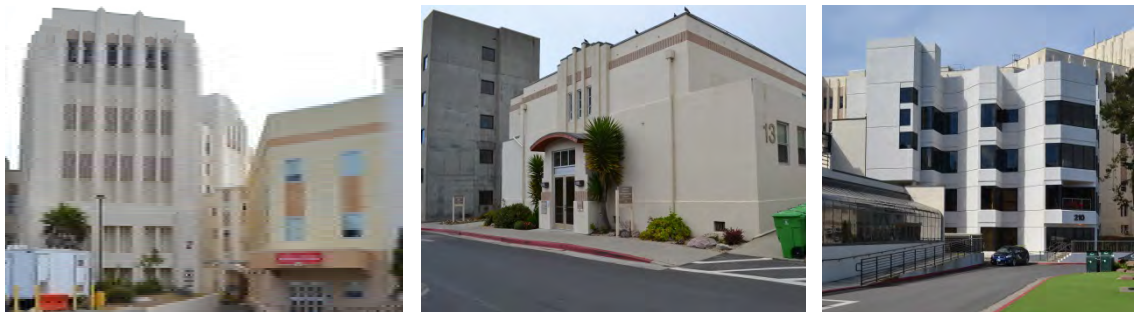
*Figure 69. Series of photographs showing the inconsistent color palette across the Historic District. From left: the off white and brown of Building 2 opposed to the yellow and orange of Building 203; Building 13 contrasting the unfinished gray concrete of the parking garage Building 209; and the bright white of Building 210 juxtaposed to the off white and brown of Building 2 (photos by HHM, 2014).*

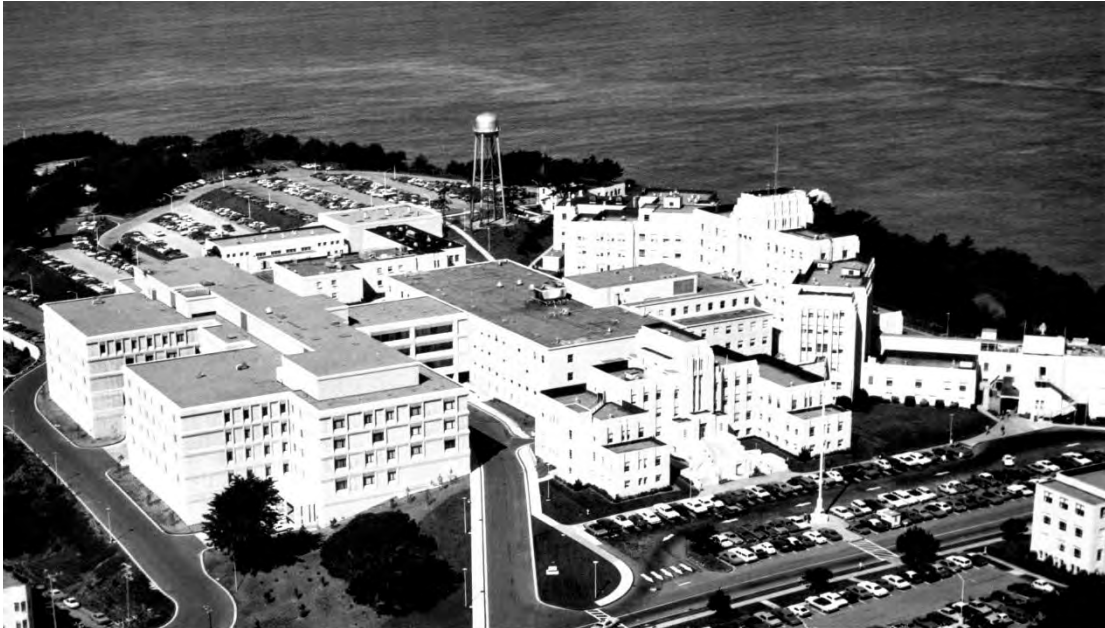
Figure 71. Aerial photograph dated 1976, showing Building 203 as originally constructed in the left foreground (courtesy of the VA).

However, Building 203's architectural integrity has been compromised over the years. When completed in 1976, it was a thoroughly contemporary textured concrete building with deeply recessed windows arranged in a staggered fenestration pattern with a staccato rhythm. Historic black-and-white photographs taken at the time of construction suggest that the color of the original concrete was compatible with the color palette of the adjacent historic buildings (see *Figure 71*). The subsequent application of a ceramic tile veneer conceals the original textured concrete, regarded as a character-defining feature of Pereira's work. In addition, the colors, mottled pattern, and shiny texture of the veneer are incompatible not only with Building 203, but also with the contributing buildings of the SFVAMC Historic District and distract attention away from them (see *Figure 72*). Building 203 thus has an ongoing adverse effect on the SFVAMC Historic District, but on the other hand, its architectural qualities and association with Pereira make it possible that it might be considered eligible for the NRHP in its own right once it approaches 50 years of age.

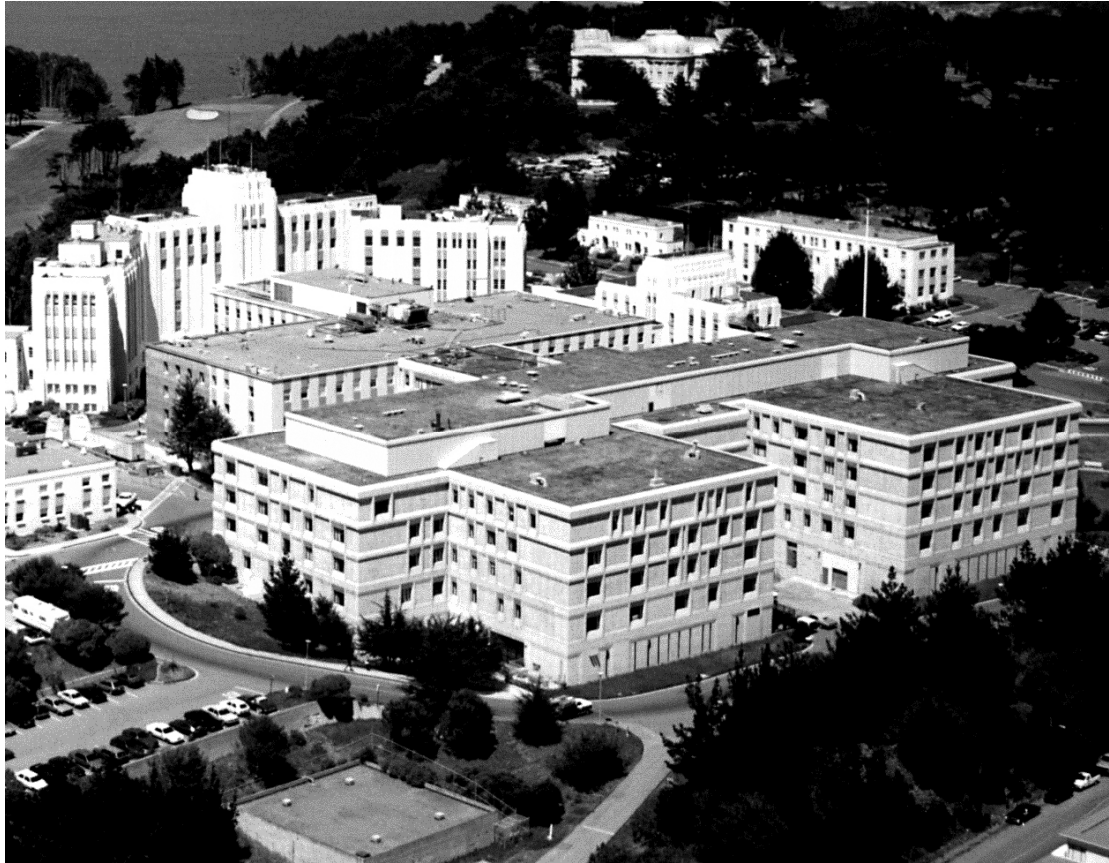
*Figure 72. View of Building 203, facing northeast, ca. 1989 (courtesy of SFVAMC).*

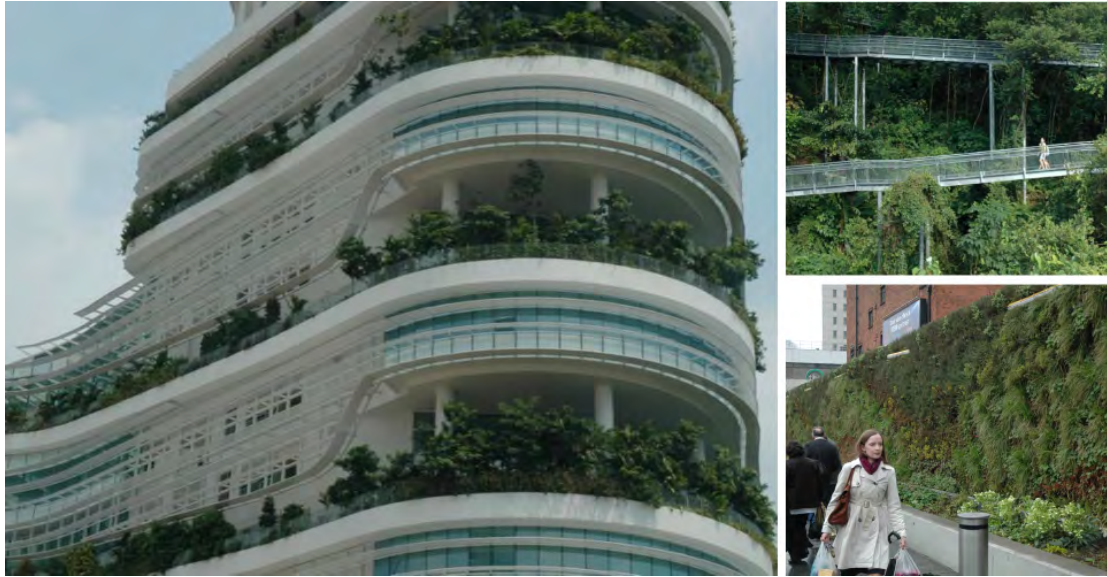
Figure 73. Examples of vegetated buildings. Source: Sakib Ahmed, "The Biophilic Cities Project," *Sustainability at the University of Virginia*, September 23, 2014, <http://www.virginia.edu/sustainability/the-biophilic-cities-project/> (accessed January 20, 2015).

Adding vegetation to the exterior walls of the parking garages, as shown in *Figure 73*, may diminish their visibility and intrusive quality and enhance the natural setting of both the SFVAMC campus and West Fort Miley. Vegetating parking garages is a low-cost option that would make the campus more aesthetically appealing and would minimize impacts on views from the FMHR Historic District.
