PUBLIC WORKS TECHNICAL BULLETIN 200-1-112
15 DECEMBER 2011

**POROUS CONCRETE LOAD-BEARING
SYSTEM AT FORT HOOD: LESSONS
LEARNED**

No. 200-1-112

APPENDIX A
POROUS LOAD-BEARING SYSTEM FEASIBILITY STUDY
AND DEMONSTRATION PROJECT

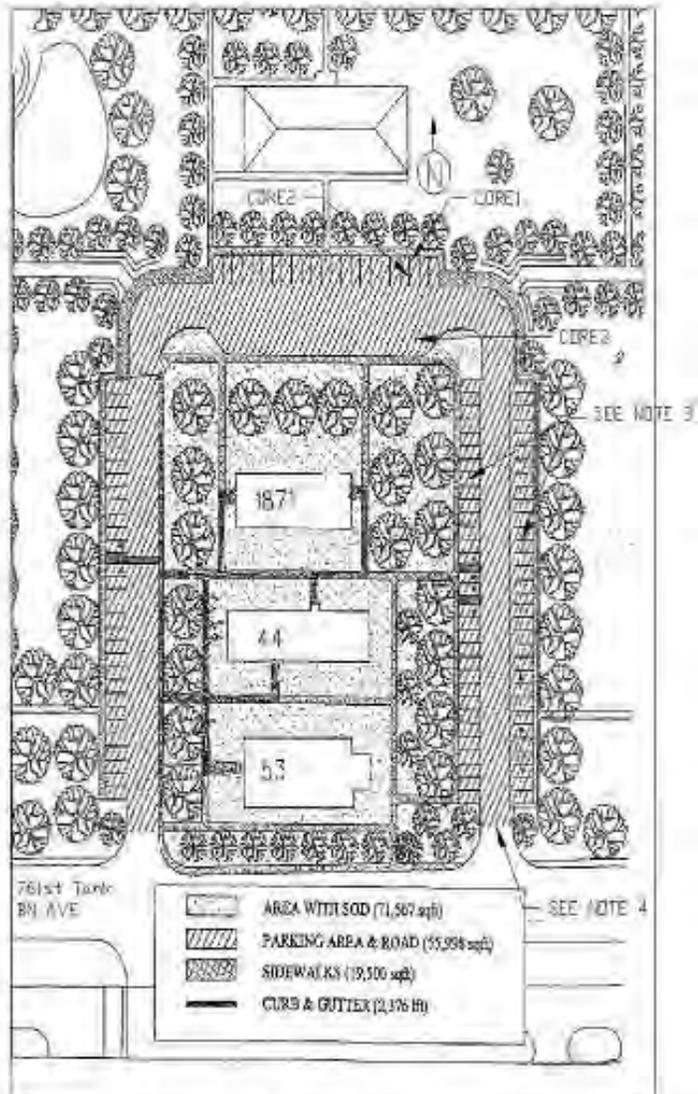
Fort Hood selected the parking lot of Building 1871 to install the porous concrete system. That lot is part of Fort Hood's renovation project called "Main Street Fort Hood Memorial Park and Historic Sites." Figure A-1 shows the proposed layout of the renovation project. As shown, the parking lot forms a horseshoe shape around Buildings 1871, 44, and 53.

Figure A-1. Proposed layout of the parking lot at Building #1871, Main Street Fort Hood Memorial Park and Historic Sites.

The sample ports were installed using a 6-in. hole saw to cut through the porous concrete (Fig A-5). A 6-in., schedule 10 steel pipe was driven through the washed gravel and into the native soil. The top of the sample port was level with the porous concrete surface. The removed porous concrete plug was then replaced and sealed around the top where it touches the sample pipe. Sample ports were planned for installation at the three locations identified on the site layout (see Figure A-1: CORE 1, CORE 2, and CORE 3).

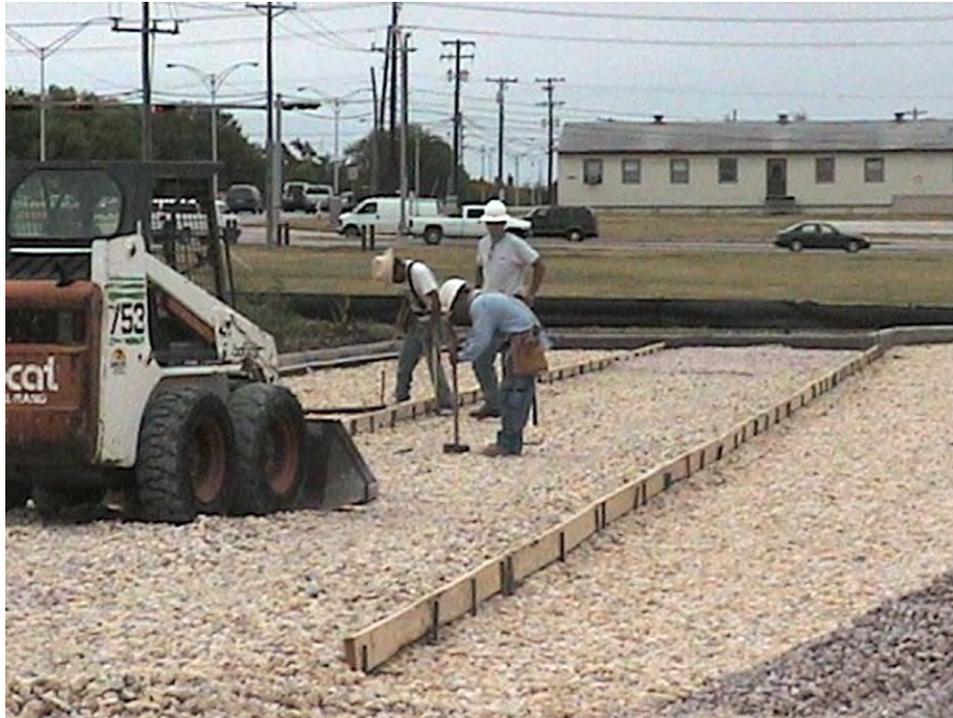
Figure A-2. Workers installing a 1 ½-in. layer of rock for the porous concrete system subsurface.

The parking lot was divided into the parking area and traffic road. The porous concrete thickness for the parking area was designed at 4 in., while the road/traffic areas were designed at 6 in. The total area of the parking lot is approximately 39,630 sq ft. Approximately 670 yd of porous concrete were installed. Figure A-2 and Figure A-3 are photographs of the parking lot during installation. Figure A-4 is a photograph of the surface of the porous concrete.

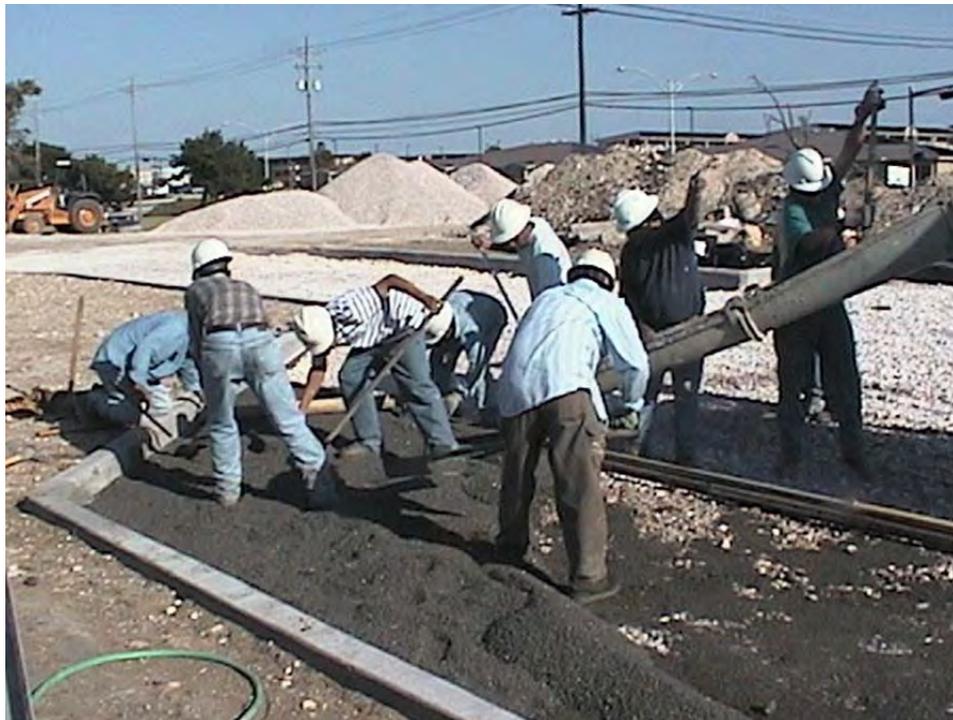
Figure A-3. Contractors installing the Ecocrete porous concrete system at Fort Hood.

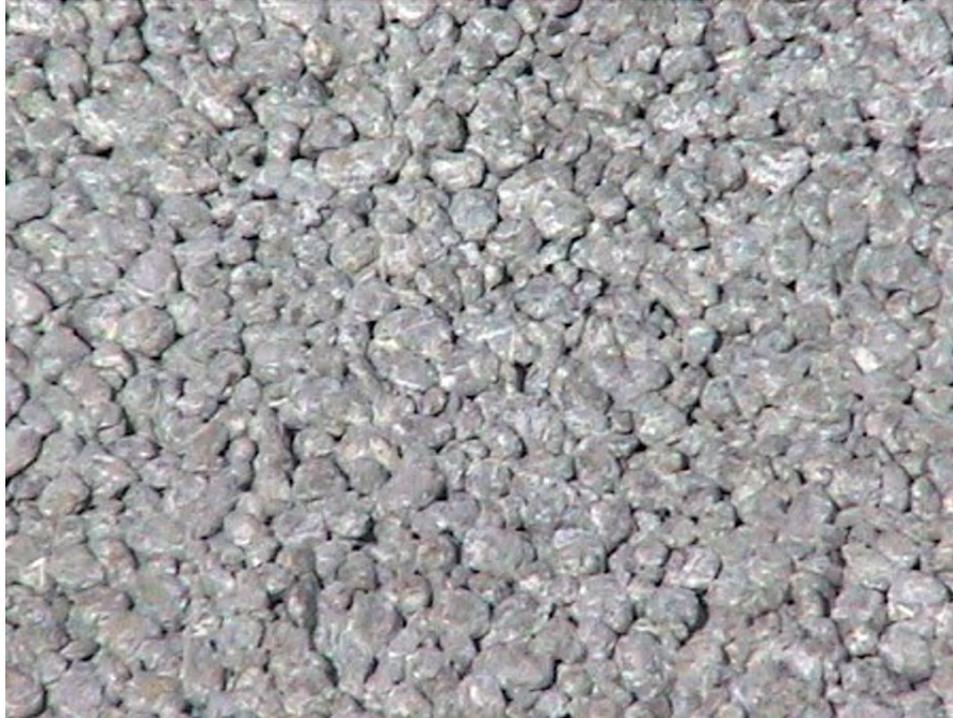
Figure A-4. The Ecocrete porous concrete finished surface.

- (1) The majority of the concrete surface of the parking lot was spalling (flaking and chipping) at the time of inspection. Also, the surface was roughly graded and had non-uniform color; this indicates improper handling, placement, curing, and finishing of the surface.

It was reported at Fort Hood that the installing contractor experienced many different problems associated with mixing and placing the Ecocreto. Apparently, there were no quality-control tests performed on the fresh concrete before or after the Ecocreto mixture was added. Subsequent discussions with Ecocreto and Fort Hood personnel indicated the contractor had numerous problems controlling the mixture prior to placement. It was also reported that the contractor attempted to slow the reaction of the mix by placing ice in it or by adding unmeasured quantities of water to the mix on site. The addition of water can be permitted after slump tests are performed; however, a final slump test should be performed to verify the slump prior to adding the Ecocreto admixture. The Ecocreto representative also stated that the contractor had sprayed the surface with water in an attempt to cure it. This action was more than likely the cause of the spalling because washing would remove cement fines, resulting in inadequate binding of the aggregate. The rough grade of the surface was probably a result of the mixture setting too fast and poor handling of the materials. Care should be taken to avoid these problems with future installations of this system.

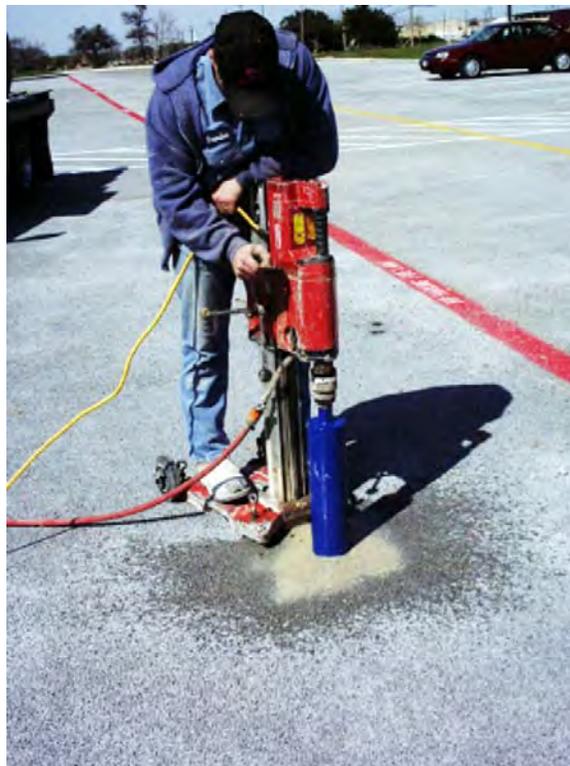
Figure A-5. Hole saw used for drilling a sample port.

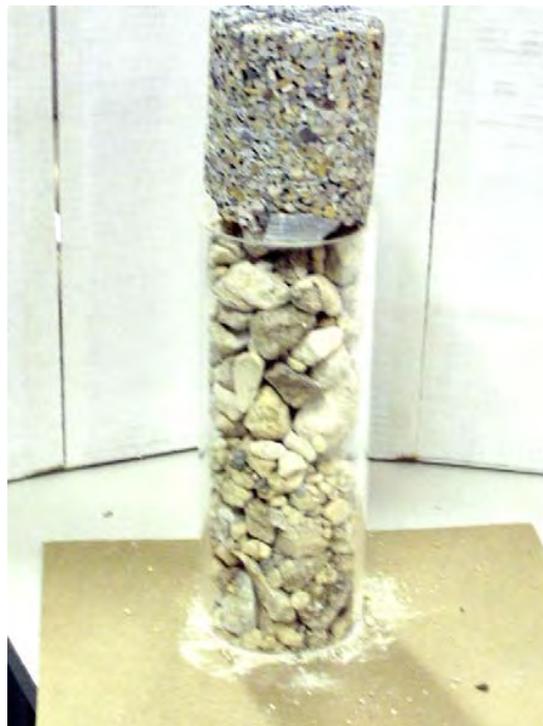
Figure A-6. Core sample from Site 2.

Based on the core samples, the actual installation could be characterized as consisting of a 1½-in. crushed, washed rock layer approximately 14 in. deep and approximately 5 in. of Ecocreto for parking areas (Figure A-6). The main driveways consist of approximately 8 in. of crushed 1½-in. washed rock and 7 in. of Ecocreto. Both areas have a heavy geotextile mat under the crushed rock.

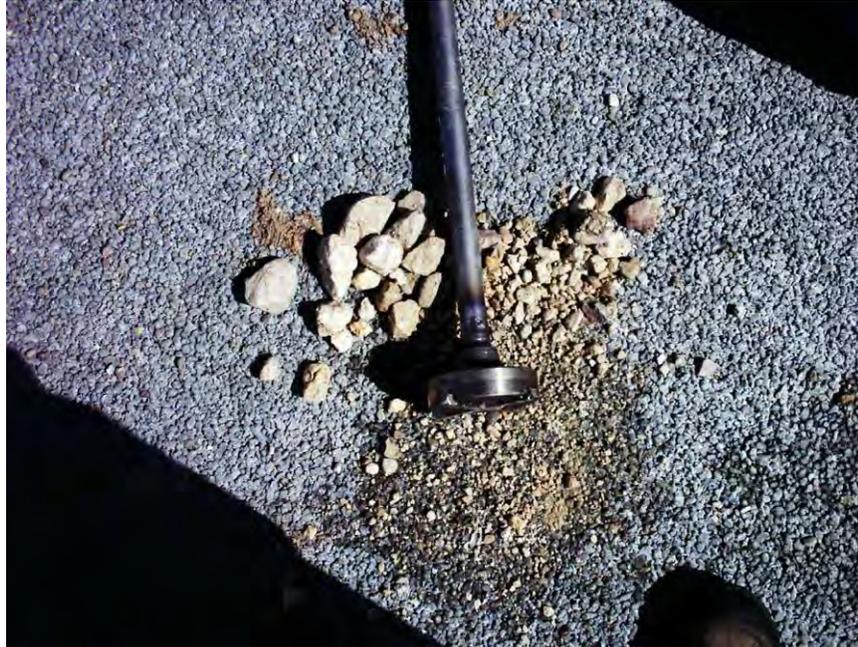
undisturbed crushed rock layer, Site 1 was only cored through the layer of porous concrete. Sites 2 and 3 were core-drilled completely to the geotextile fabric. A sample pipe was placed in Site 1 down to the crushed rock layer. The core from Site 2 was completely removed and a sample pipe was placed in the hole to form an apparent seal with the geotextile fabric and clay soil (it was not possible to verify this seal). This hole was intended to determine the permeability of the fabric liner and underlying soil. Site 3 was used to approximate the combined permeability of the concrete and rock layers. The cylindrical pavement core was left in the hole after being cut out with the hole-saw tool. The hole saw left a circle-shaped gap between the core and the surrounding pavement that allowed a sample pipe to be forced into the hole, putting the core inside the pipe. Figure A-6 is a photograph of the core taken from sample Site 2. Some gravel removed from a sample port (Figure A-7) indicated that the crushed rock had not been completely washed. This meant it had some tendency to absorb water and become sticky, which is not ideal for best drainage.

Figure A-7. Poorly washed gravel removed from a sample port.

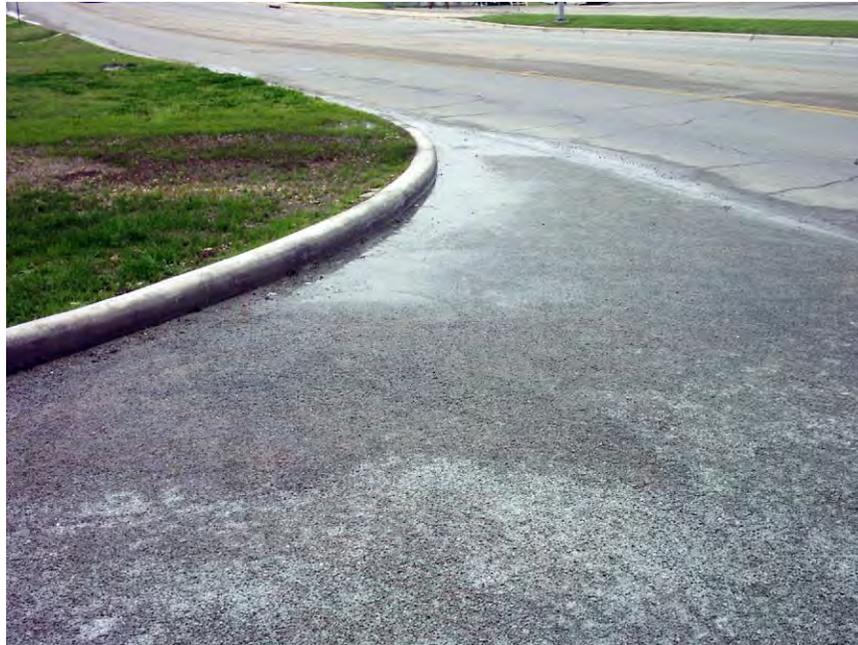
- (2) A light rainfall occurred during the night of 1 March 2005, and the porous pavement installation was inspected the following morning. Ponding was not observed on the parking lot surface, which could have meant the concrete surface was indeed porous. However, water was observed exiting from the parking lot at the southeast driveway (Figure A-8). Water then flowed east along the curb until it reached a storm drain approximately 150 yd from the parking lot. This observation indicated the system did not retain water as desired.

Figure A-8. Water seeping from the southeast end of the parking lot.

The initial intent of the project was to implement a porous system that would be designed with the capacity to retain water from a significant precipitation event with subsequent infiltration of runoff into the native soil. The Ecocreto representative indicated that there is a pore space volume of 40%-46% in the sub-base material (crushed washed rock). This is supported by inspection of the subgrade after removal of the core samples. However, this pore space was not being used to retain water, which was evident by the volume of water observed flowing from the parking lot. With the elevation drop of 4 ft from the entrance at the northeast corner to the exit at the southeast corner, the porous concrete structure appeared to be operating as a subsurface drain channel for the water captured by the parking lot rather than for storage.

It is recommended that future porous concrete systems be designed and installed to ensure the capture of stormwater from a significant precipitation event and to allow enough retention time for the stormwater to exfiltrate to the underlying soil.

Designers should verify the infiltration capacity of the soil prior to site selection and construction of a porous pavement system. Engineers should confirm that the slope of the underlying soil is such that water will be retained until infiltration occurs.
