FIGURE U-3
ISOMETRIC OF COMPLETED STACK JOINT
UNITIZED CURTAIN WALL SYSTEM

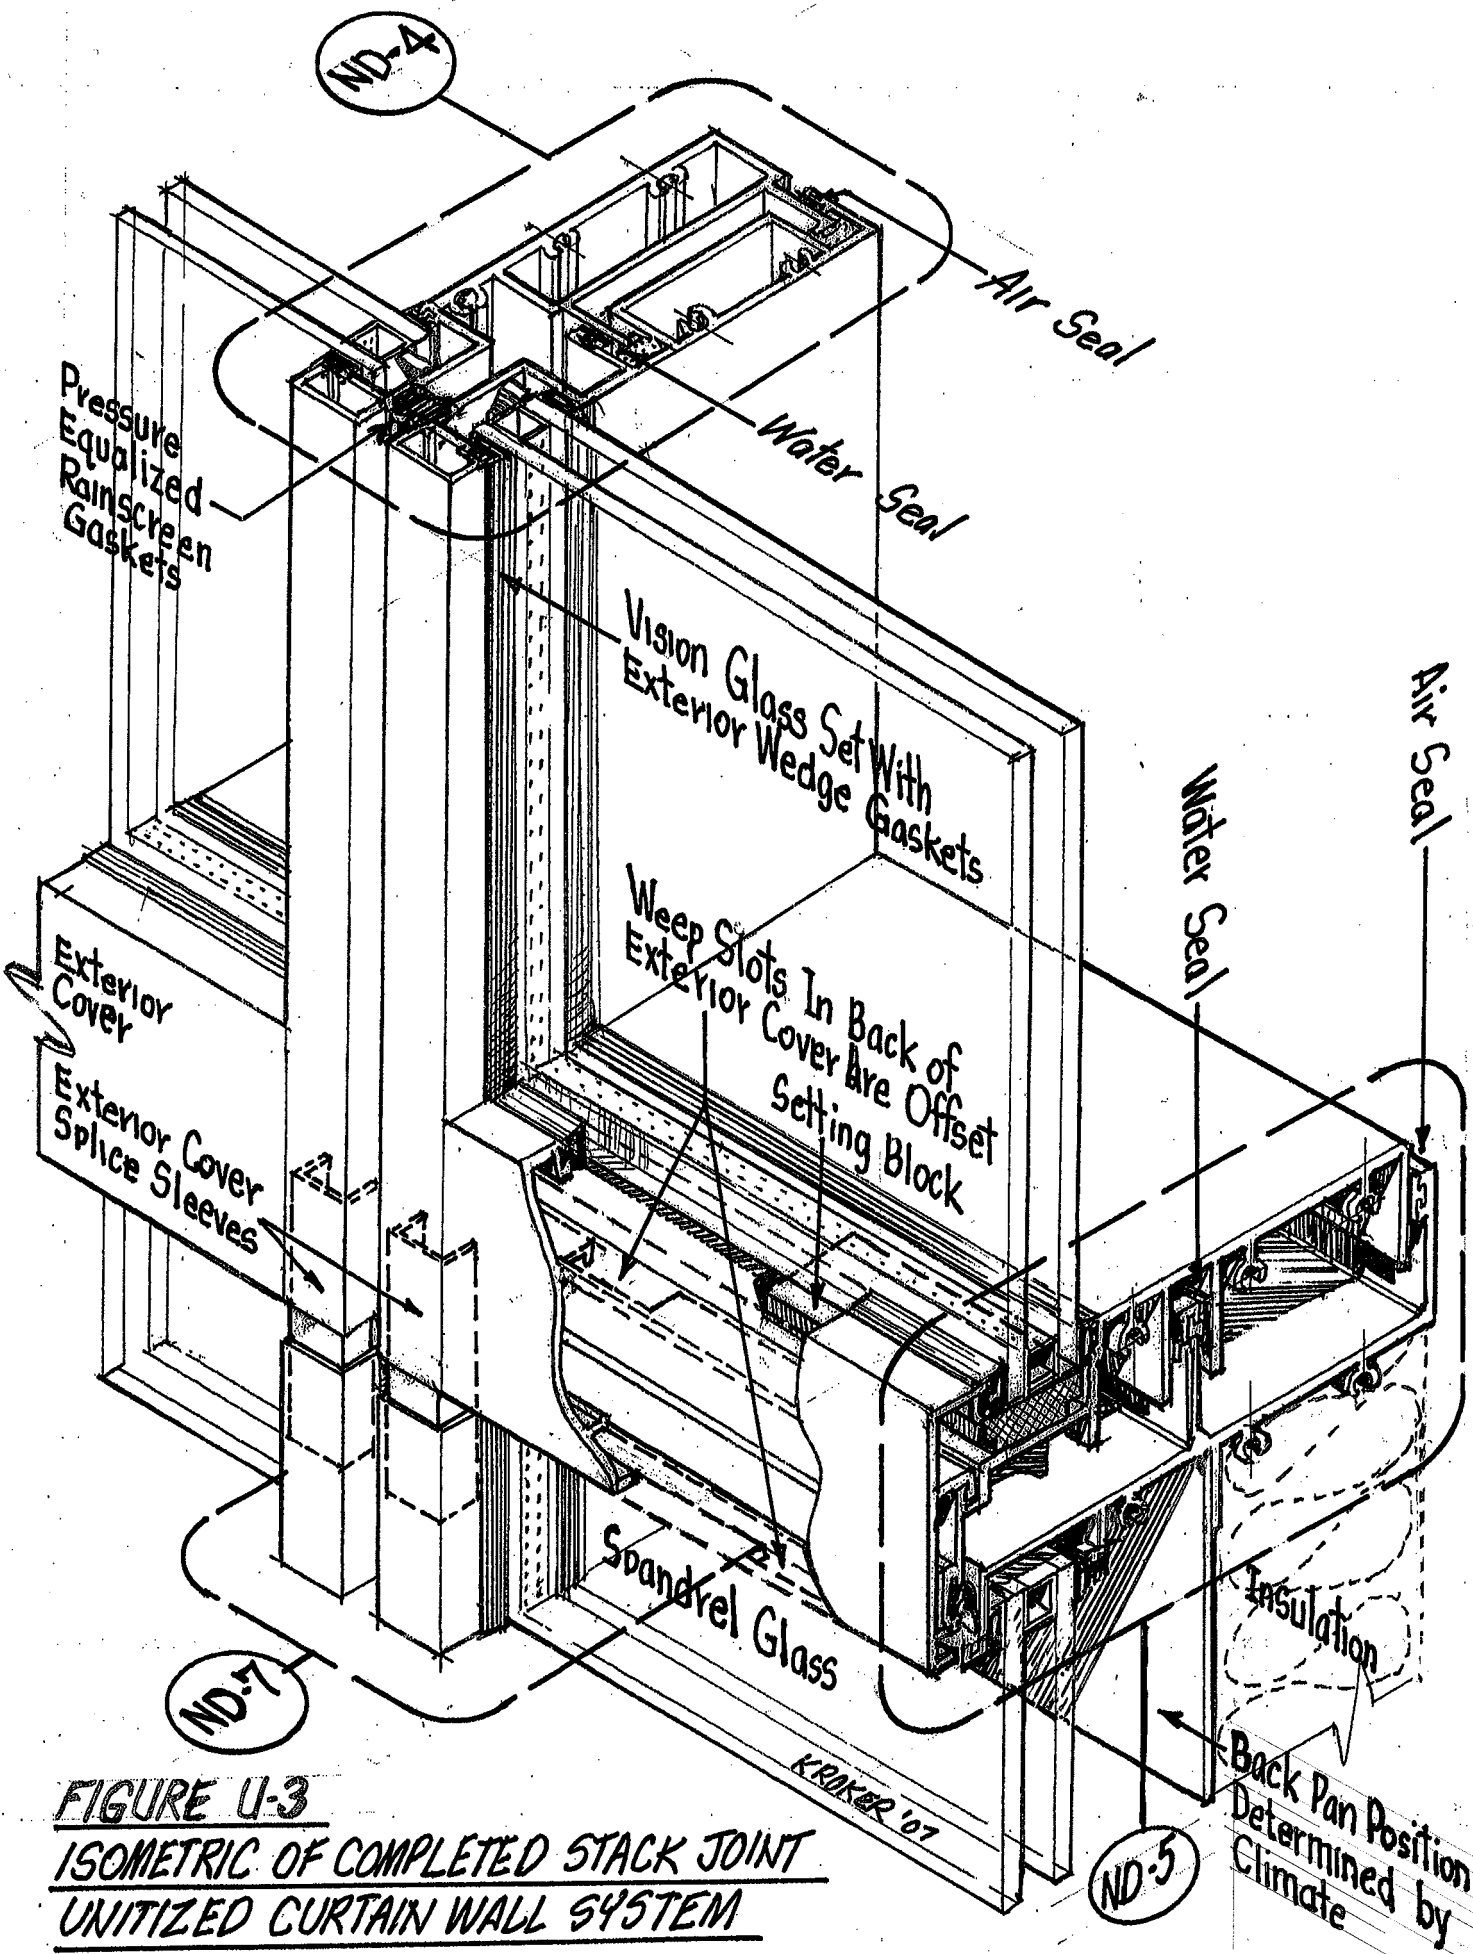
ND-5

Back Pan Position
 Determined by
 Climate
